July 2010

Slope Stability Assessment Proposed Development Site 101 Wurtemberg Street Ottawa, Ontario

Submitted to:
Claridge Homes Corporation
2001-210 Gladstone Avenue
Ottawa, Ontario
K2P 0Y6

Report Number: 10-1121-0003

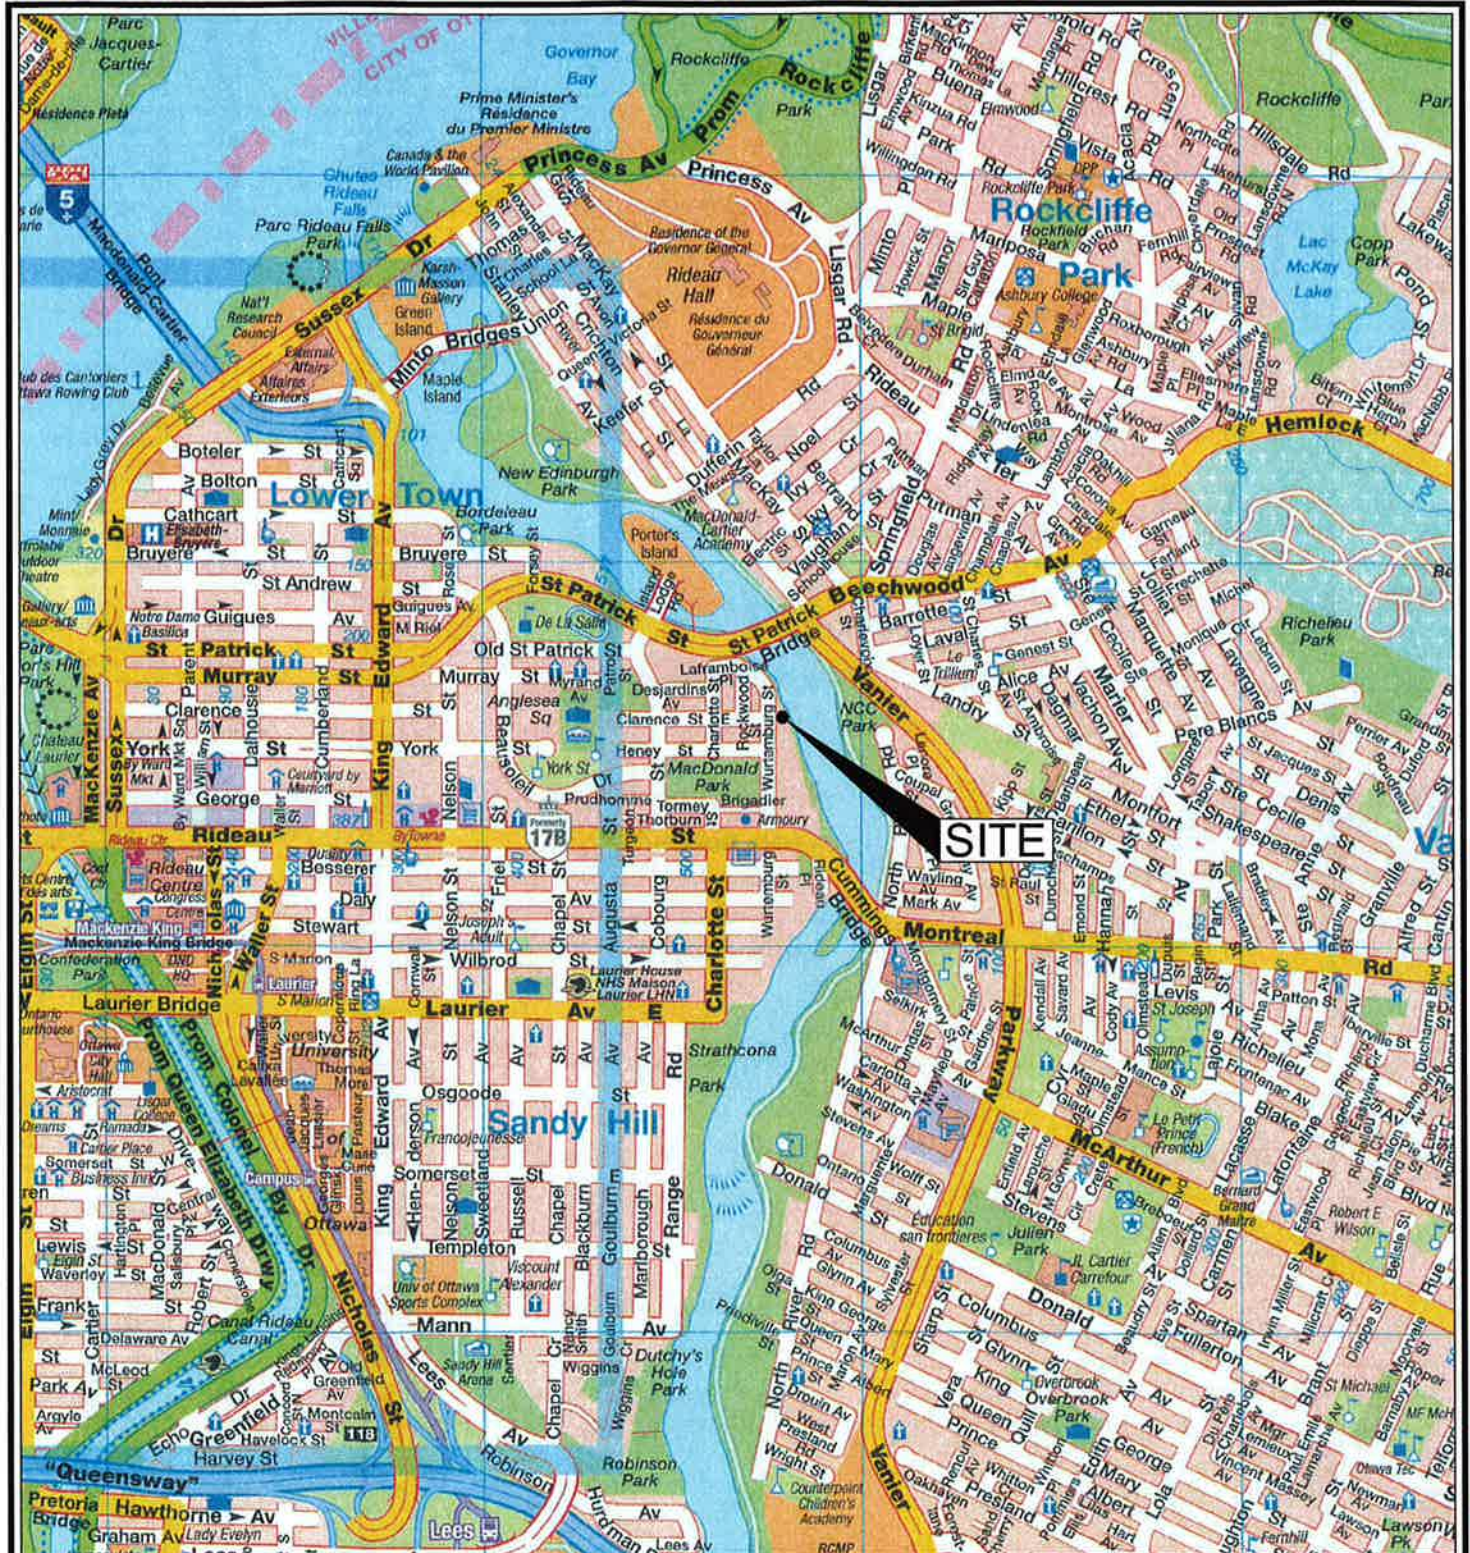
The resulting Limit of Hazard Lands for this site is shown on the Site Plan, Figure 2.

Additional set-back distance (to define the Limit of Hazard Lands) could also be required to allow for an ‘Erosion Allowance’. An Erosion Allowance needs to be applied wherever there is active erosion, or the potential for active erosion based on the flow velocities. The Rideau Valley Conservation Authority provided flow velocities for floods with return periods ranging between 5 and 100 years. Those flow velocities range from 1.2 to 1.3 metres per second. These velocities are considered to be at about the threshold value above which erosion could be expected. It is therefore considered that the magnitude of the *Erosion Allowance* for this site, based on the MNR guidelines, would be 8 metres. The corresponding Limit of Hazard Lands is also shown on Figure 2.

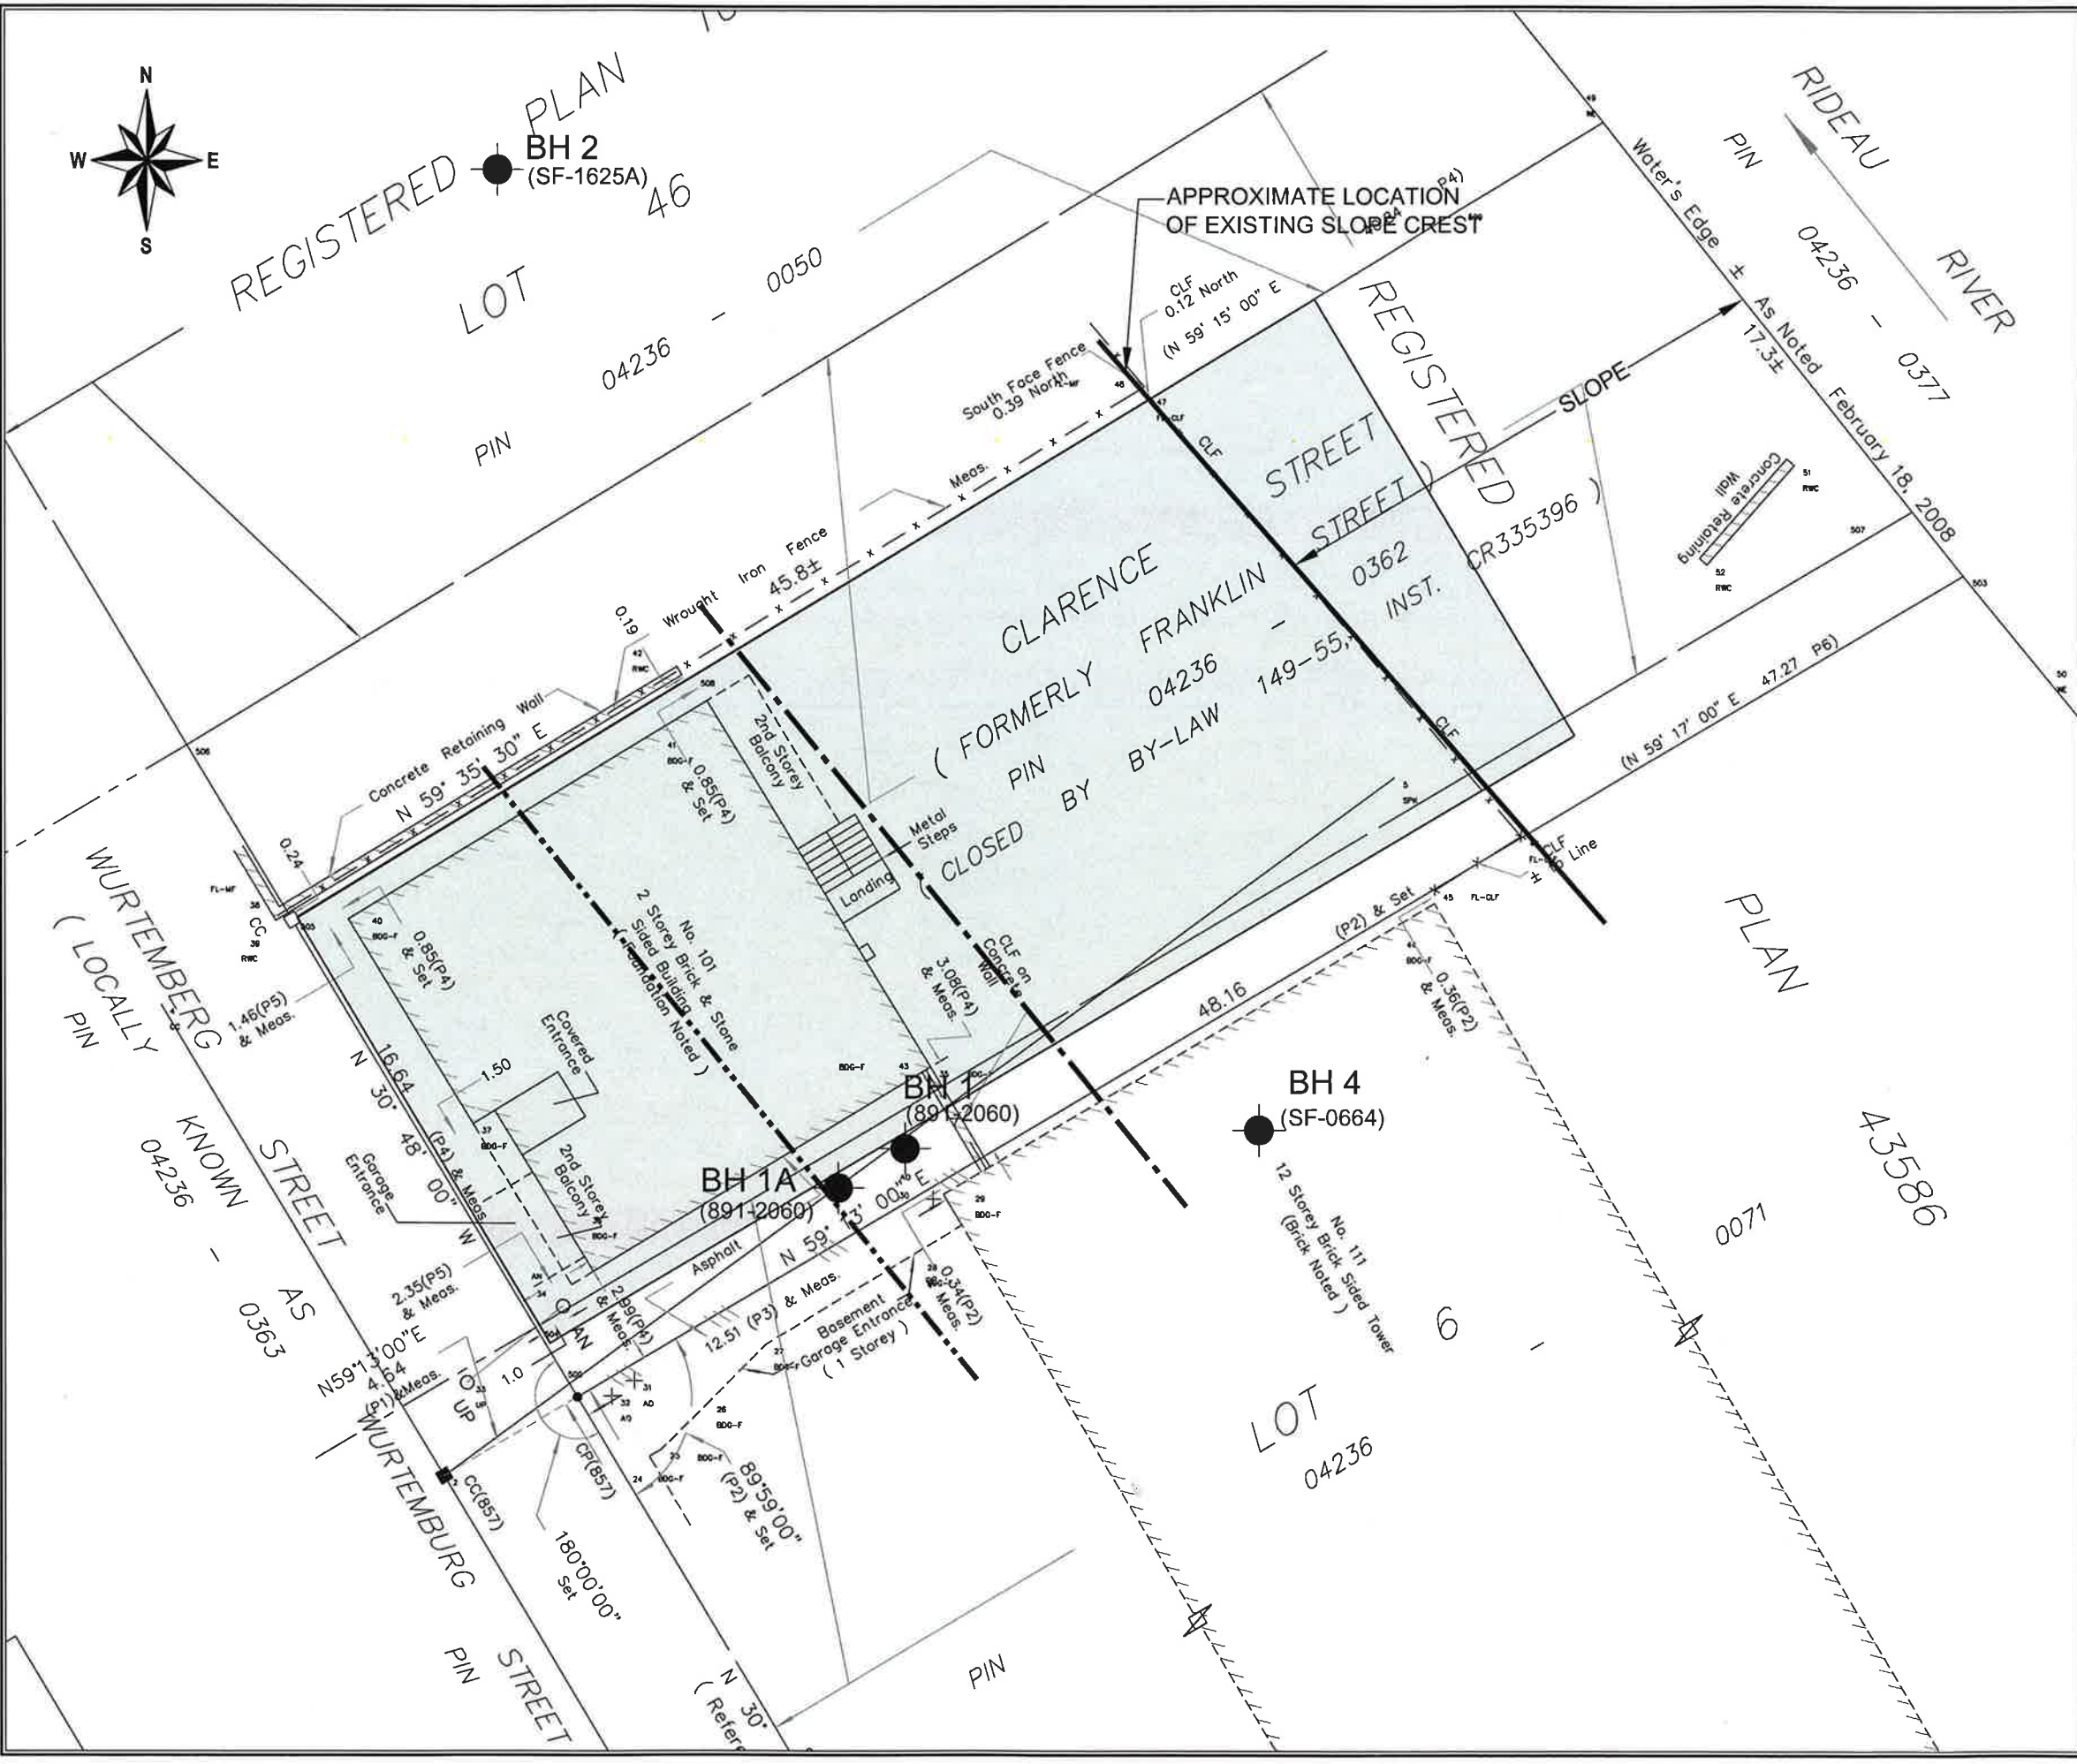
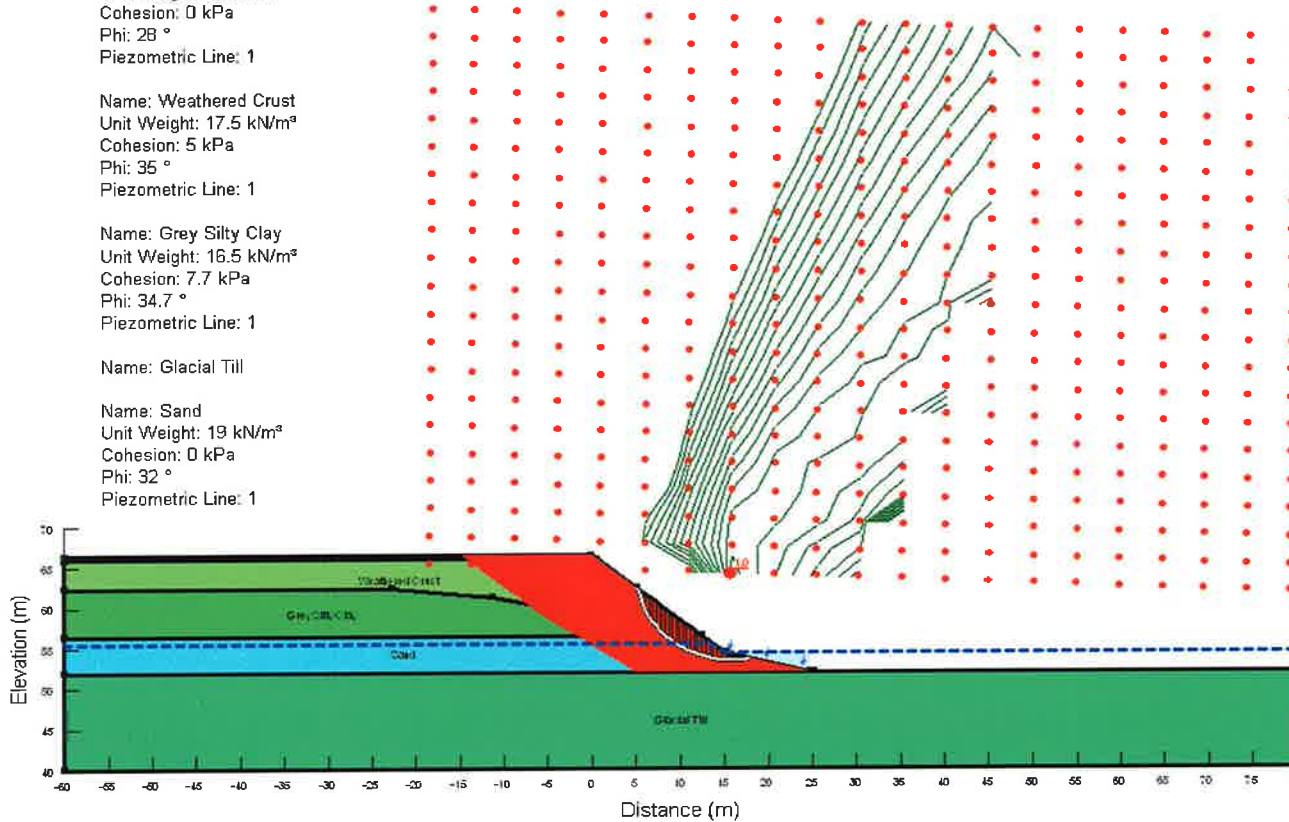
Figure 3

For static loading conditions, the results of the stability analyses indicate that the existing slope generally has a factor of safety against instability of about 1.0 and is therefore unstable. It is considered that the slope has maintained its current steep geometry as a product of the advantageous effects of the under-drainage from the sand layer and the reinforcing effects of the vegetation.

These analyses indicated a factor of safety of about 0.8, which is less than desired value of 1.1. However the potential failure surfaces with factors of safety less than 1.1 are all confined to the lower portion of the slope face and would not jeopardize the table land area.

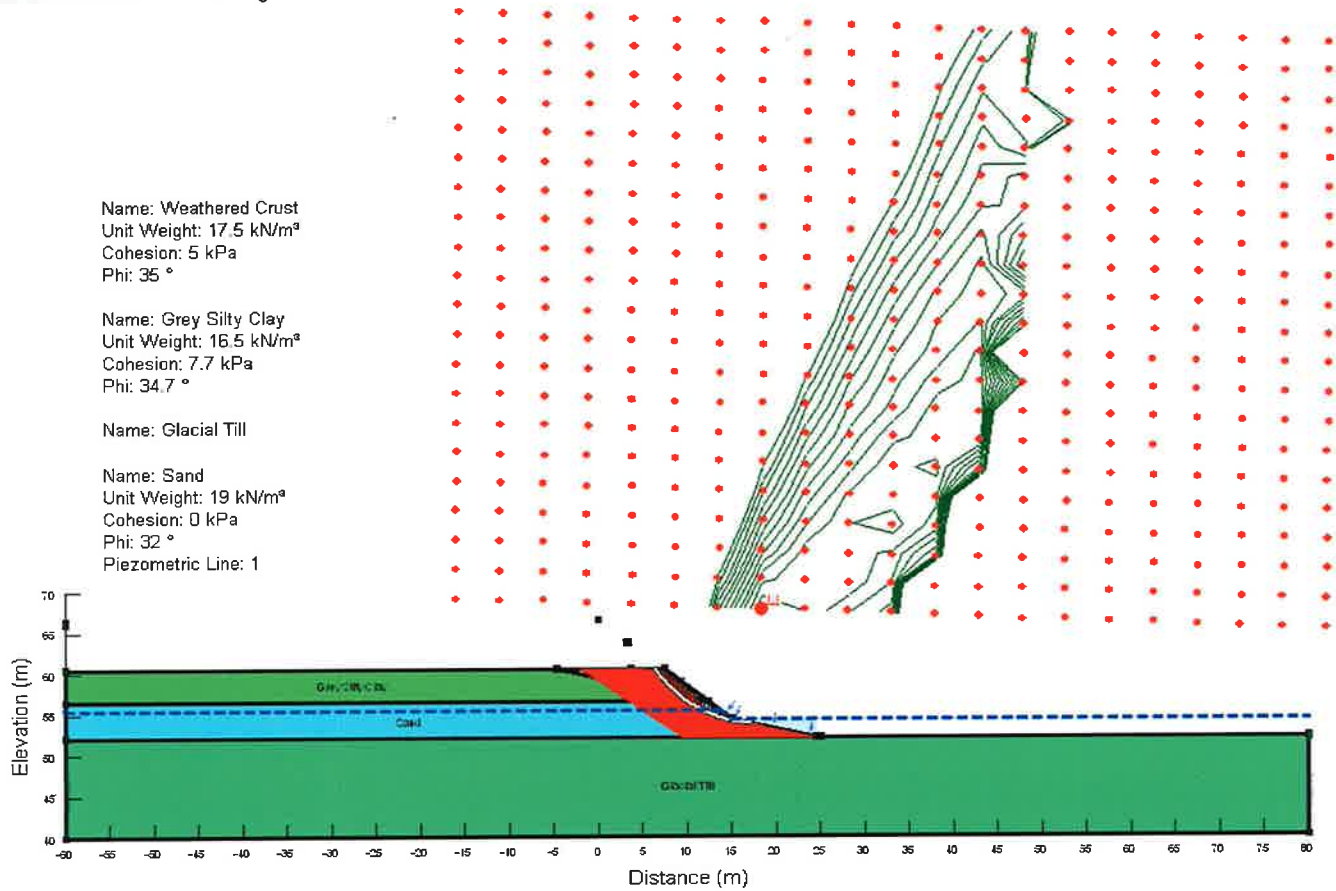
Figure 4	REVIEW	MJC	3/27/10
	CHECK	KE	5/27/10
	CADD		
	DESIGN	KSL	06/29/10
	REV. 0	SCALE AS SHOWN	
FILE No.	PROJECT No. 10-1121-0003

The stability analysis results for the proposed slope geometry are shown on Figure 4. These results indicate that the proposed slope would have a factor of safety against instability of about 1.1 and is therefore unstable. The Stable Slope Allowance for this case would be about 10 metres (for a factor of safety of 1.5), as measured from the slope crest. The potential slope failures could therefore extend beneath the building area (although the building itself would be supported on piles).

Therefore, regardless of whether or not the slope is flattened, the factor of safety against instability of the slope would be too low. Although the potential instability would not directly jeopardize the integrity of the building (because it would be supported on piles), the potential slope failures could expose the foundations, possibly undermine the basement floor slab, and destroy any terrace areas.

Therefore, based on the current understanding of the risk/hazard, the objectives of the project, and the costs involved, the option of excavating and re-constructing the slope with a geogrid reinforced Mechanically Stabilized Earth (MSE) system is the preferred method to achieve an adequate factor of safety (greater than 1.5 for static loading and greater than 1.1 for seismic loading) for the proposed development condition.

The recommended option is therefore to re-construct the slope with an MSE system.
