**Claridge Homes  
Wurtemberg Street Condominium Development  
Ottawa, Ontario**

April 19, 2010

Project Number: GP 10106

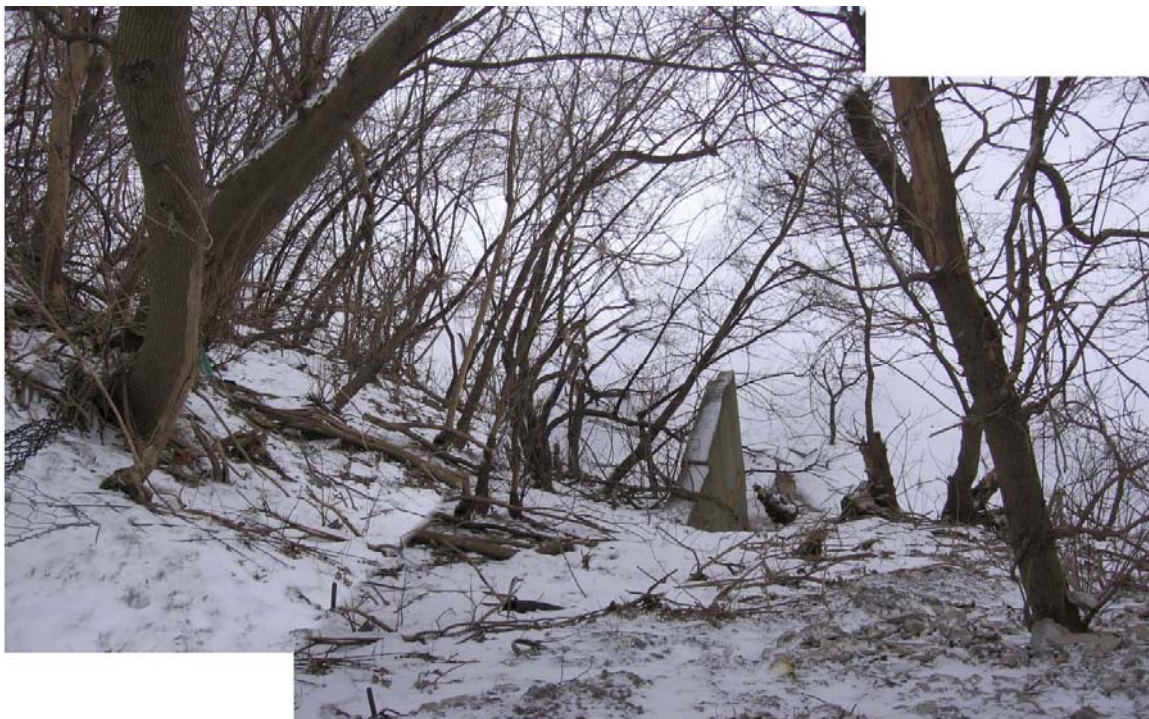
Photos 1, 2 and 3 in Appendix 1 depict the slope of the property and foreshore along the Rideau River on February 21, 2010. On the side adjacent to the Rideau River, the property slopes steeply toward the river as indicated in Photos 1 and 2. The slope is vegetated with trees and shrubs. Although it did not appear as though there was extensive ground cover, the ground was covered with snow on February 21, 2010 and this was difficult to confirm.

Photo 1. View down slope to the Rideau River on February 21, 2010. The concrete abutment is the upstream extent of the development property.

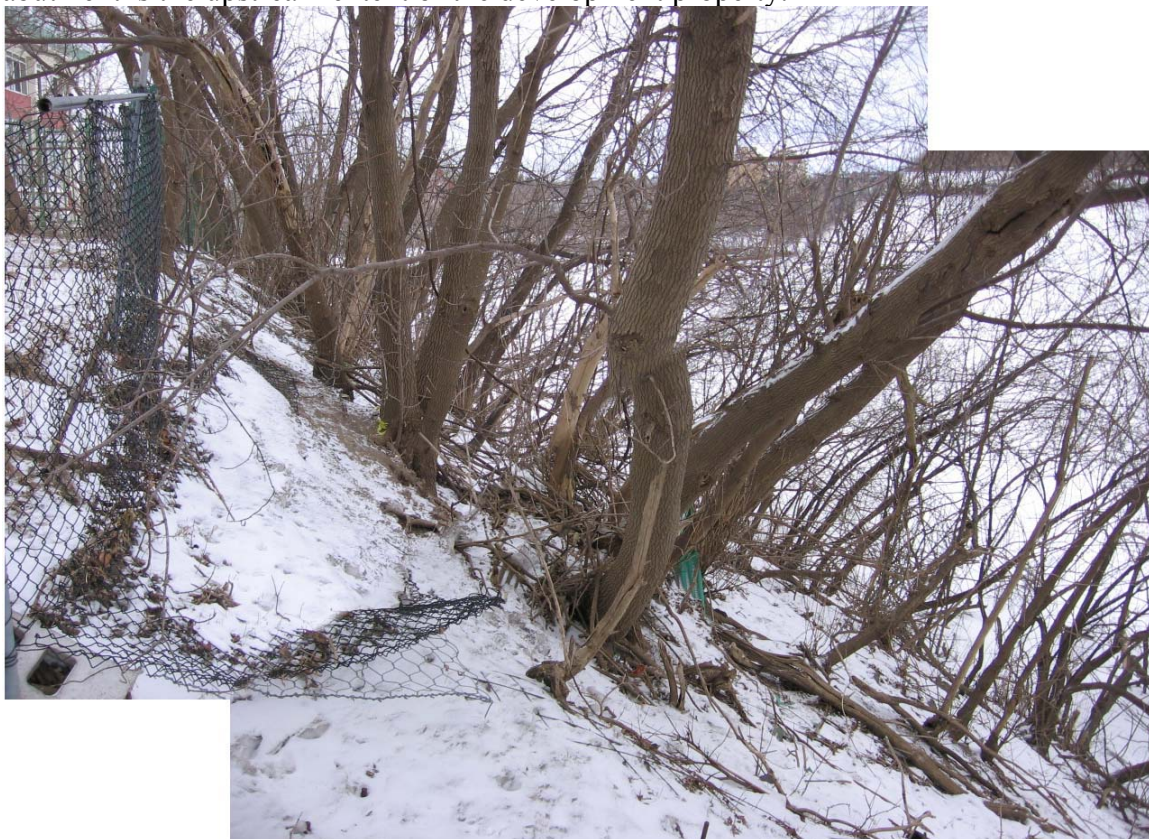
Photo 2. View across the slope on February 21, 2010. The fence represents the top of the slope on the development property.

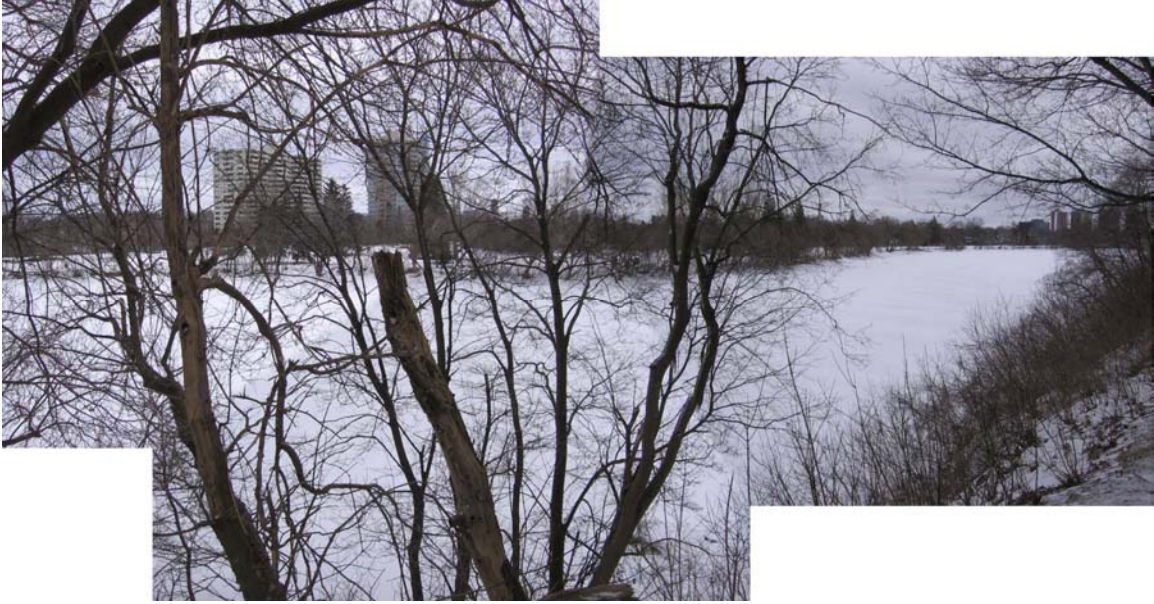
Photo 3. View along the Rideau River looking upstream from the upstream side of the development property, on February 21, 2010.

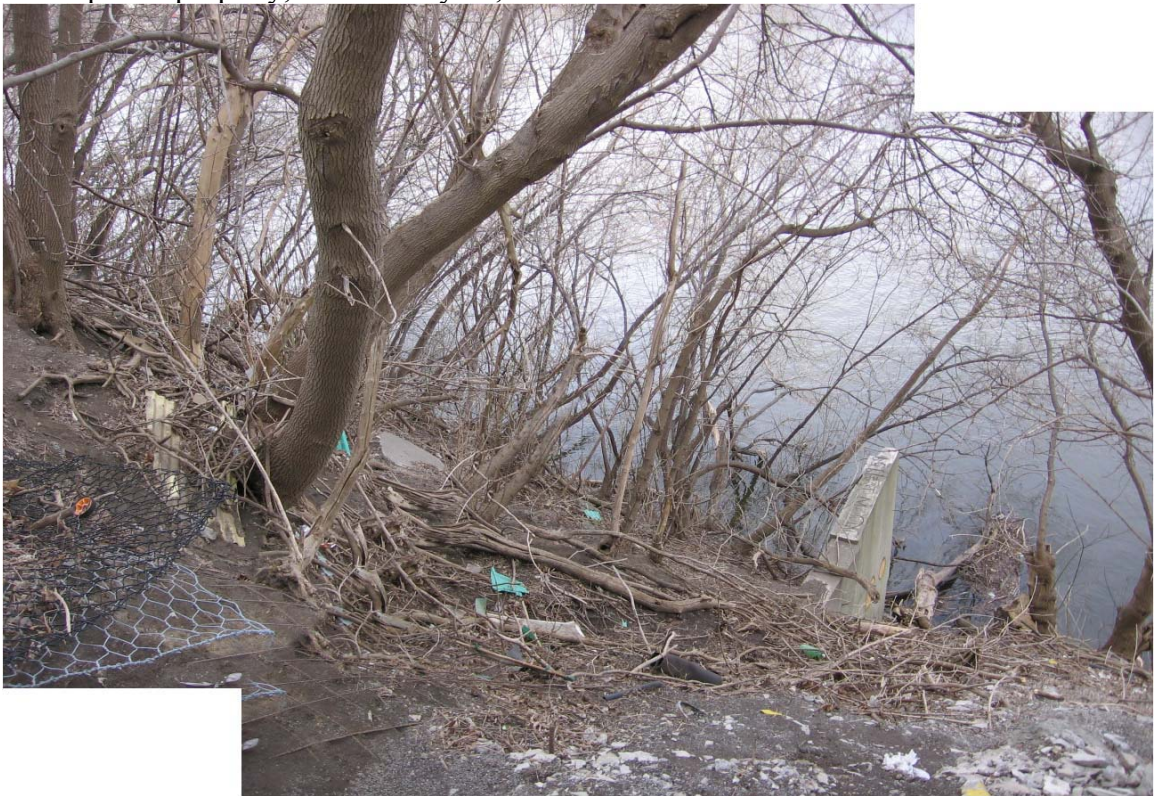
Photo 4. View down slope to the Rideau River on March 25, 2010. The concrete abutment is the upstream extent of the development property.

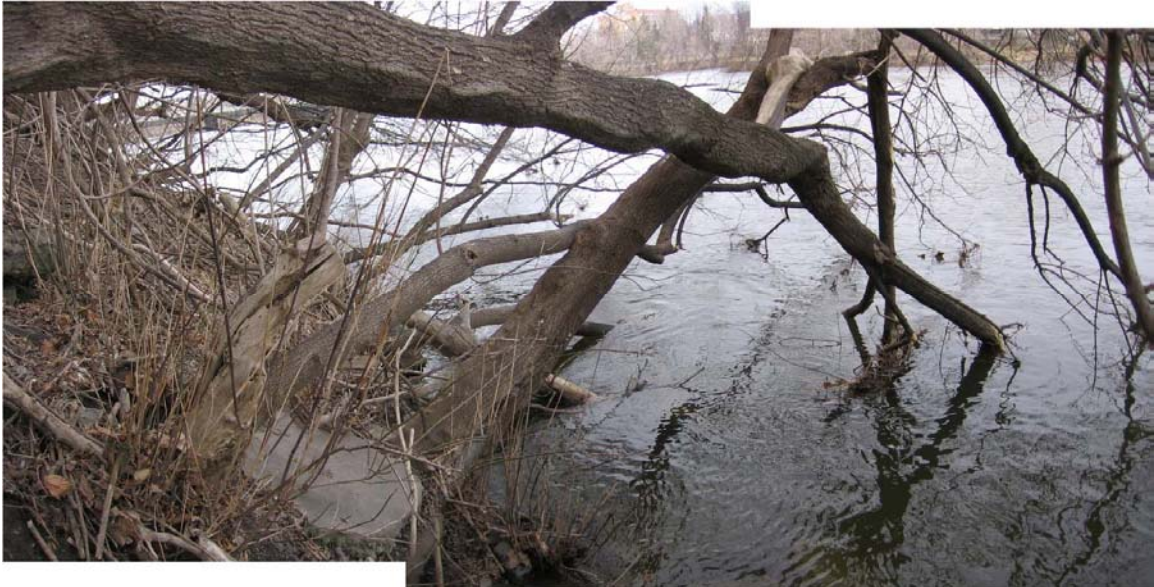
Photo 5. View along the foreshore of the Rideau River, looking downstream from the upstream side, on March 25, 2010.

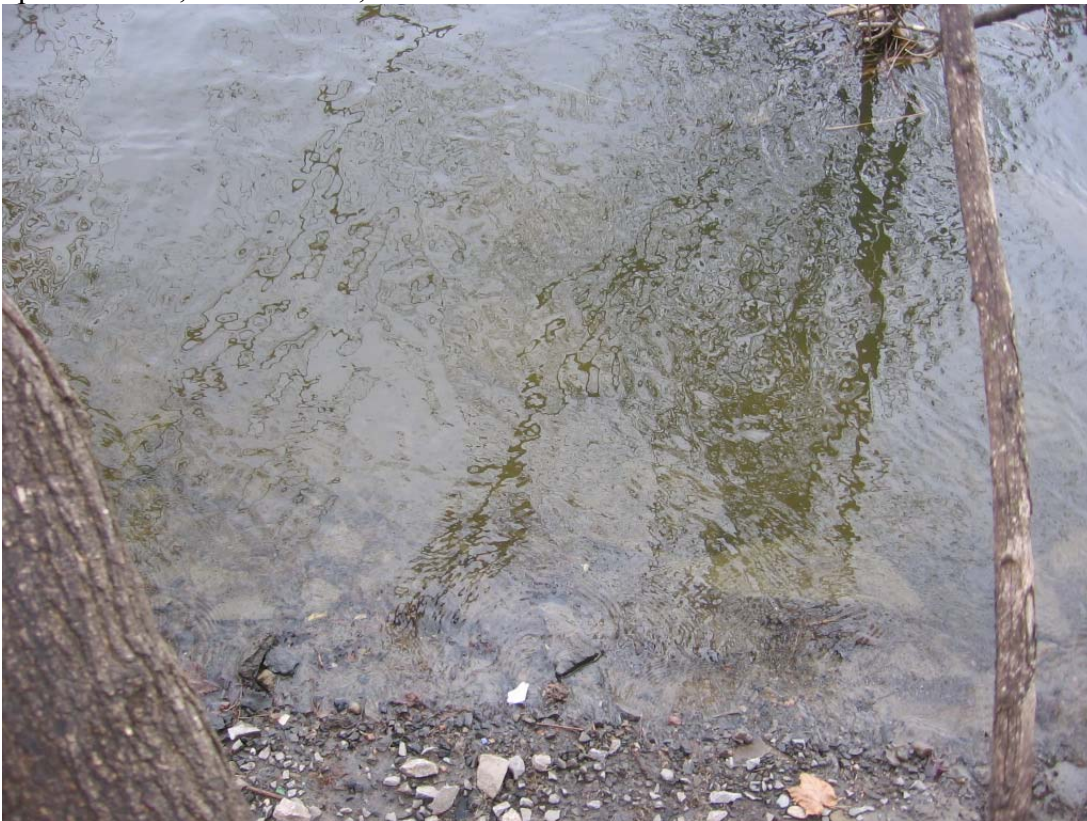
Habitat Resiliency	<ul style="list-style-type: none"> <li>• The shoreline habitat currently present at the site is a mix of broken concrete and related granular material, along with a mix of fine particle substrate and gravel, as indicated in Photos 6, 7 8, 12, 13 and 16 in Appendix 1. It can be seen from the photos that the gravel is fairly embedded.</li> <li>• The shallow littoral habitat is comprised of a sloping silty substrate (Photos 14 and 15), with some large woody debris present.</li> <li>• The Manitoba maples overhang the shoreline providing shade. There is virtually no understory.</li> <li>• Generally, along this section of river, the littoral habitat (Photos 10 and 11) is similar to that depicted in Photos 6, 7 and 8 in Appendix 1. The property immediately downstream has a concrete retaining wall however (Photo 10).</li> <li>• Golder Associates (2010) indicates that the existing bank is erosional and the slope is unstable. This was also noted in the site visits reported upon in this report. Placement of rip-rap is intended to correct this ongoing source of habitat alteration.</li> <li>• Structure provided by large woody debris can be replaced by rip-rap. If necessary, large woody debris could be placed with the rip-rap.</li> <li>• Overhanging vegetation can be replaced with appropriate species of shrubs.</li> </ul>

Photo 6. Close-up of the littoral zone along the front of the property showing substrate and degree of embeddedness - March 25, 2010

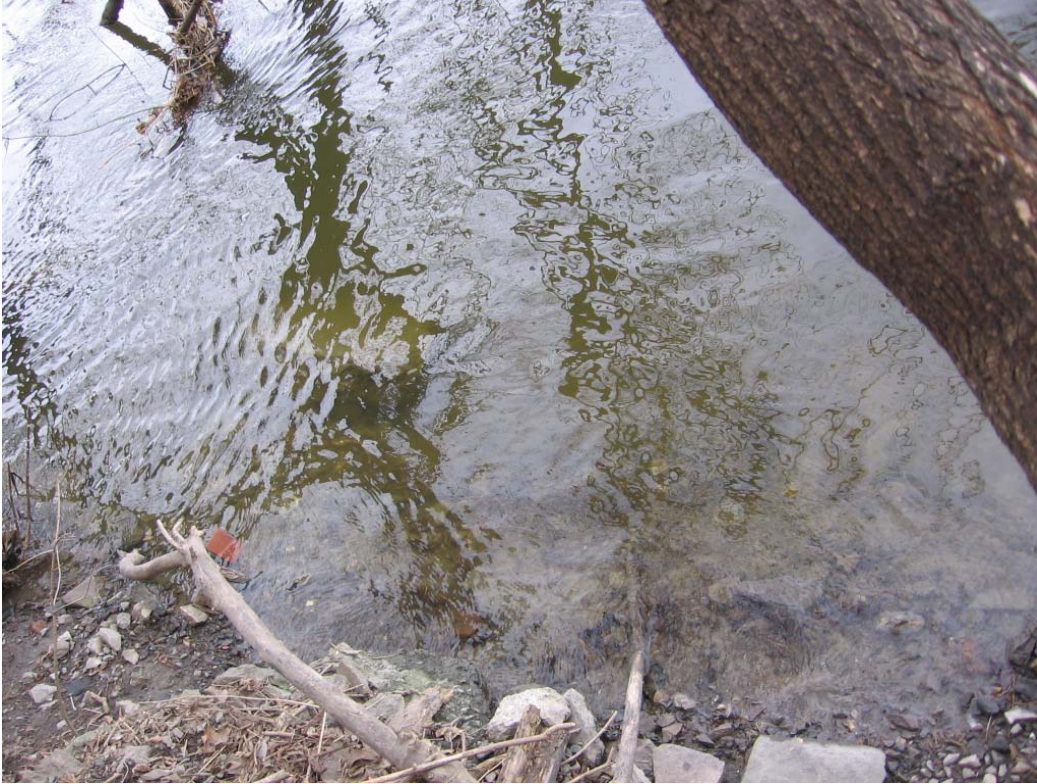
Photo 7. Close-up of the littoral zone along the front of the property showing substrate, habitat structure and degree of embeddedness - March 25, 2010.

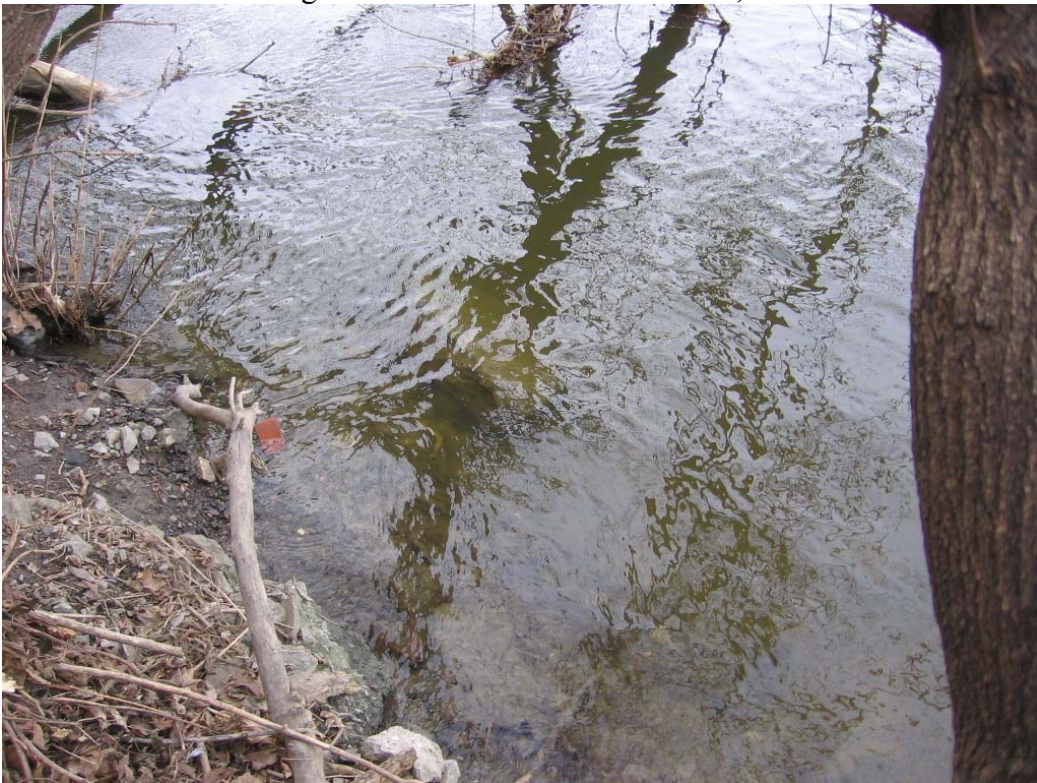
Photo 8. Close-up of the littoral zone along the front of the property showing substrate, habitat structure and degree of embeddedness - March 25, 2010.

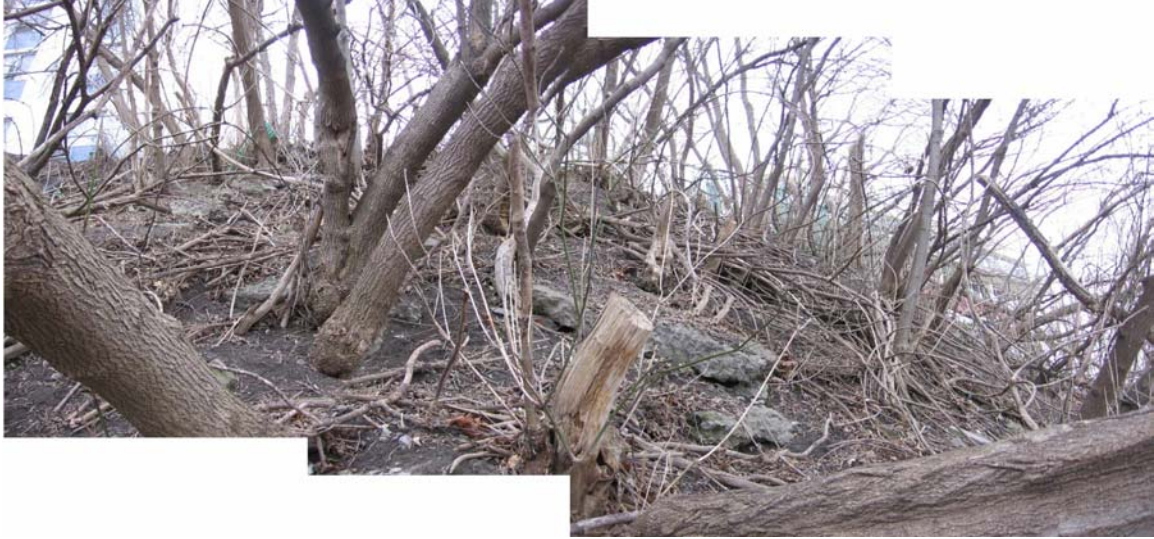
Photo 9. View from the water looking upslope - March 25, 2010.

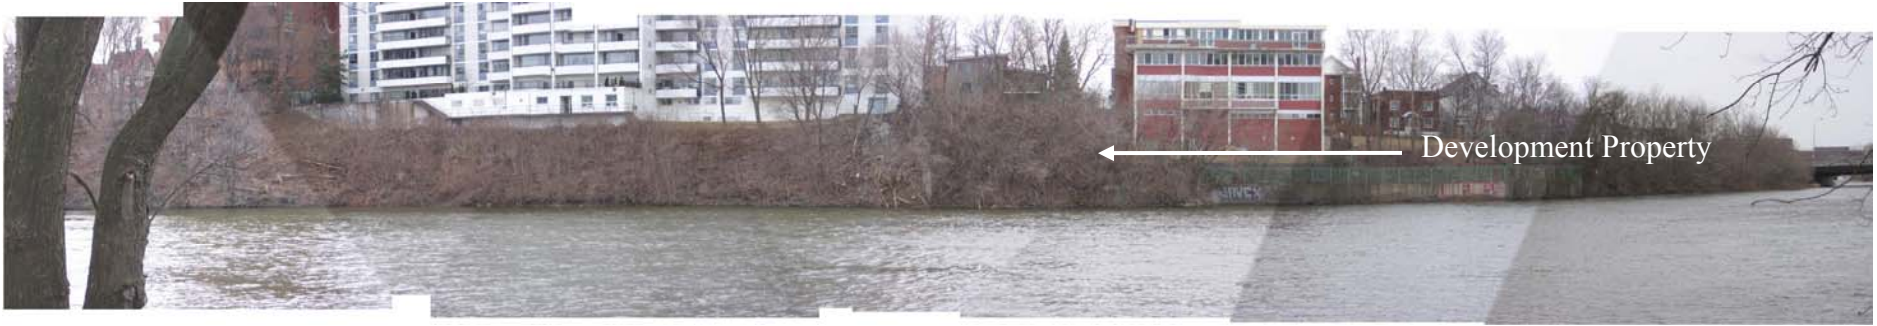
Photo 10. View of the property and adjacent shoreline from across the Rideau River - March 25, 2010.

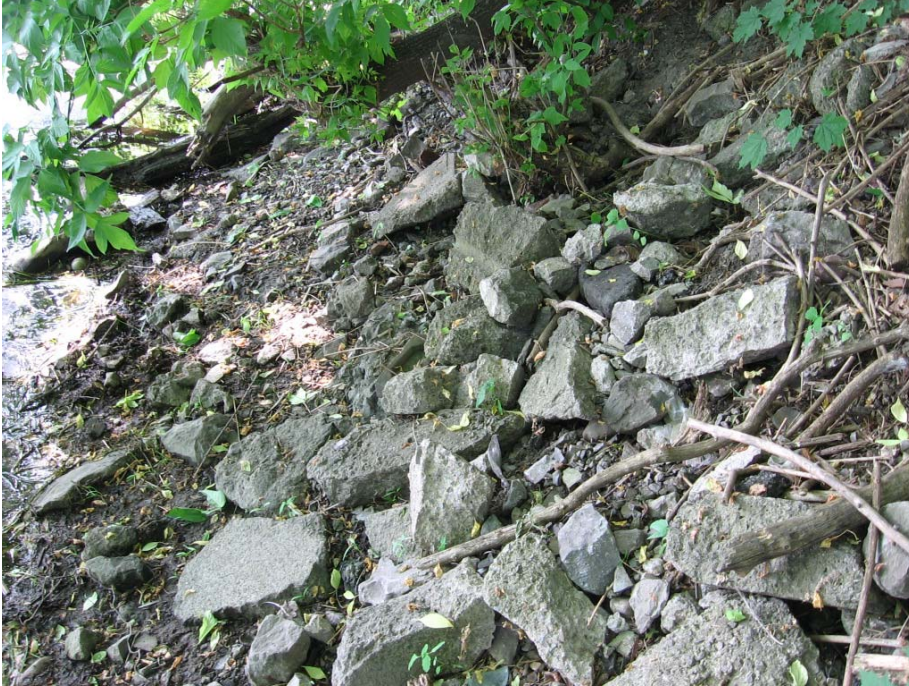
Photos 12 through 16 in Appendix 1 depict the Rideau River shoreline and shallow littoral zone along the property on May 25, 2010. From Photos 12, 13 and 16 it is apparent that the shoreline has a substantial component that is comprised of broken concrete and granular material. Photos 14 and 15 show the shallow littoral zone where the substrate is comprised of silty material. Some submergent aquatic vegetation and a minor amount of large woody debris were present.

Photo 12. Shoreline showing broken concrete that has been moving downslope toward the river – May 25, 2010.

Rip-rap at the toe of the slope would extend approximately 2 meters into the littoral areas of the adjacent Rideau River for a distance of 17.3 meters. Approximately 35 square meters of fish habitat would be altered by the placement of rip-rap at the toe of the slope. Rip-rap would also be placed on the slope itself, meaning that existing vegetation would be removed. Trees would be planted along the toe of the slope, through spaces between the rip-rap.

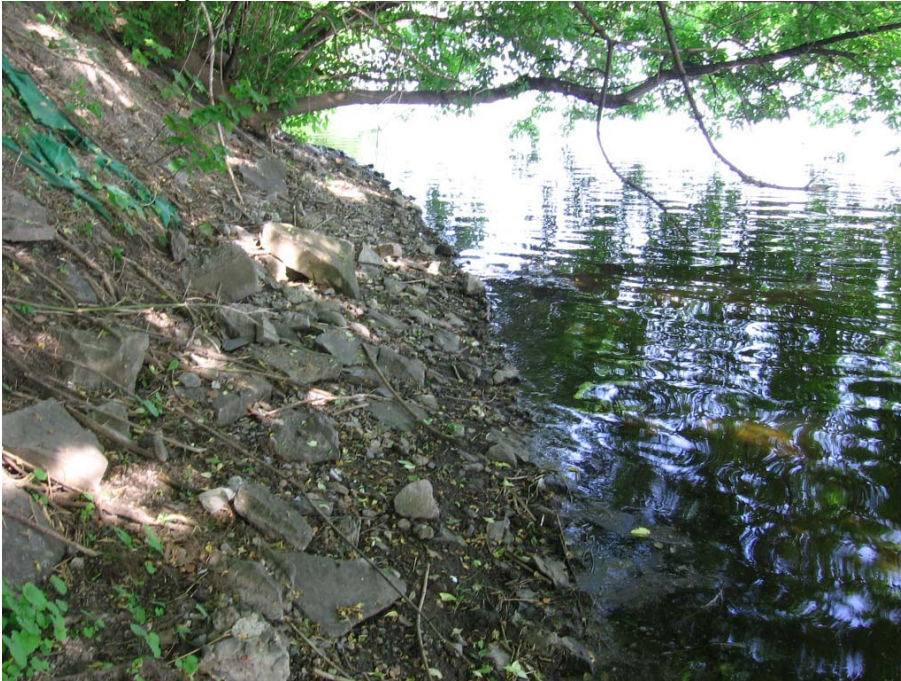
Photo 13. Shoreline showing broken concrete and unconsolidated material that has been moving downslope toward the river. While the Manitoba maples provide overhead shade, the shoreline itself lacked riparian vegetation – May 25, 2010.

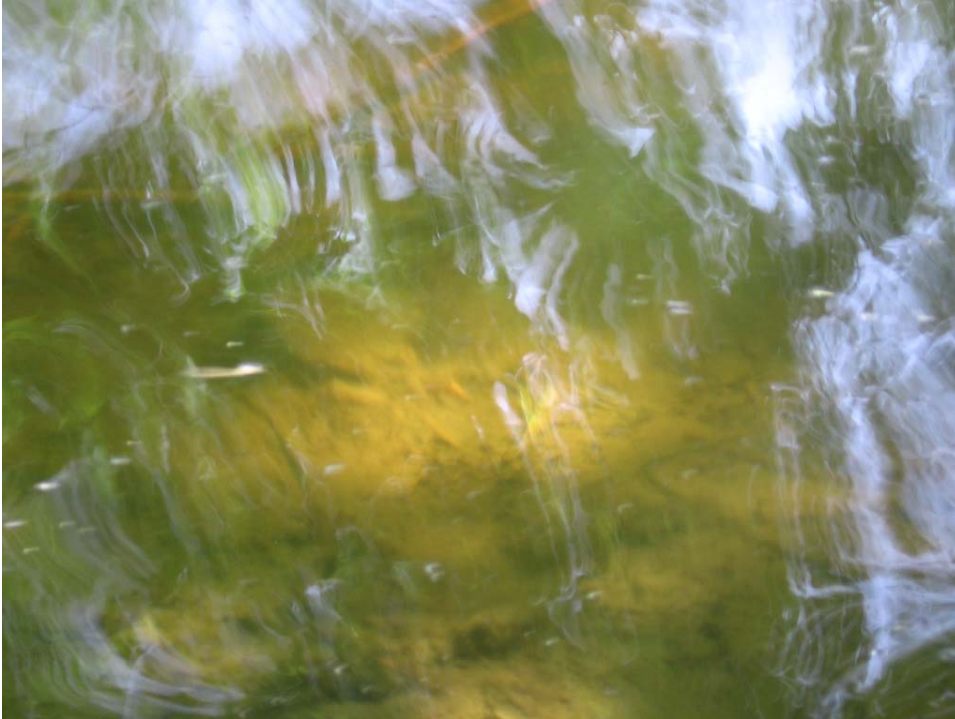
Photo 14. View of silty substrate in the shallow littoral zone – May 25, 2010.

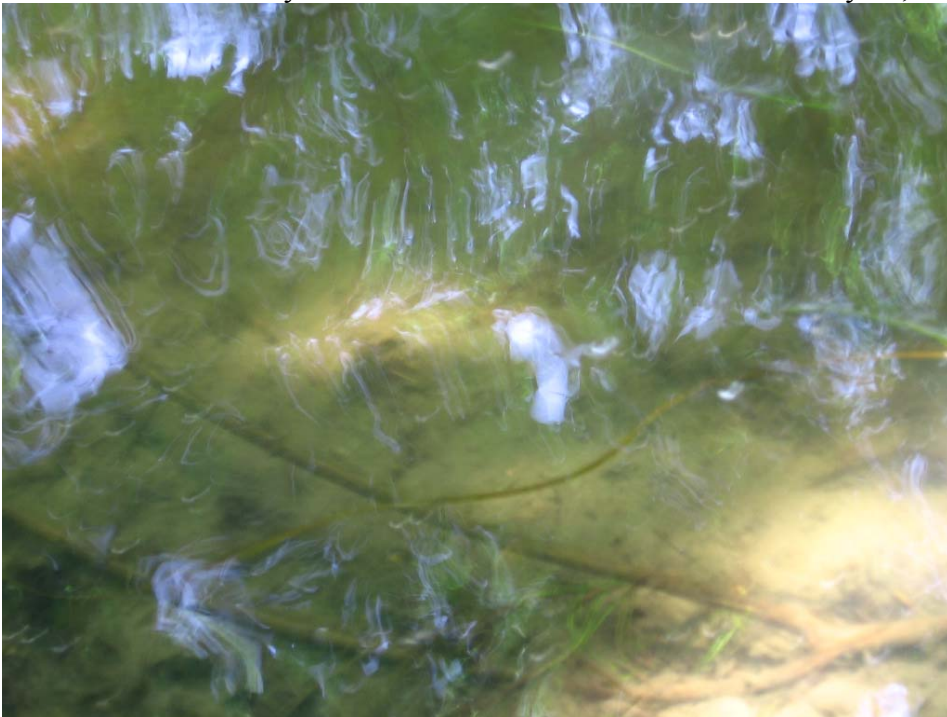
Photo 15. View of silty substrate in the shallow littoral zone – May 25, 2010.

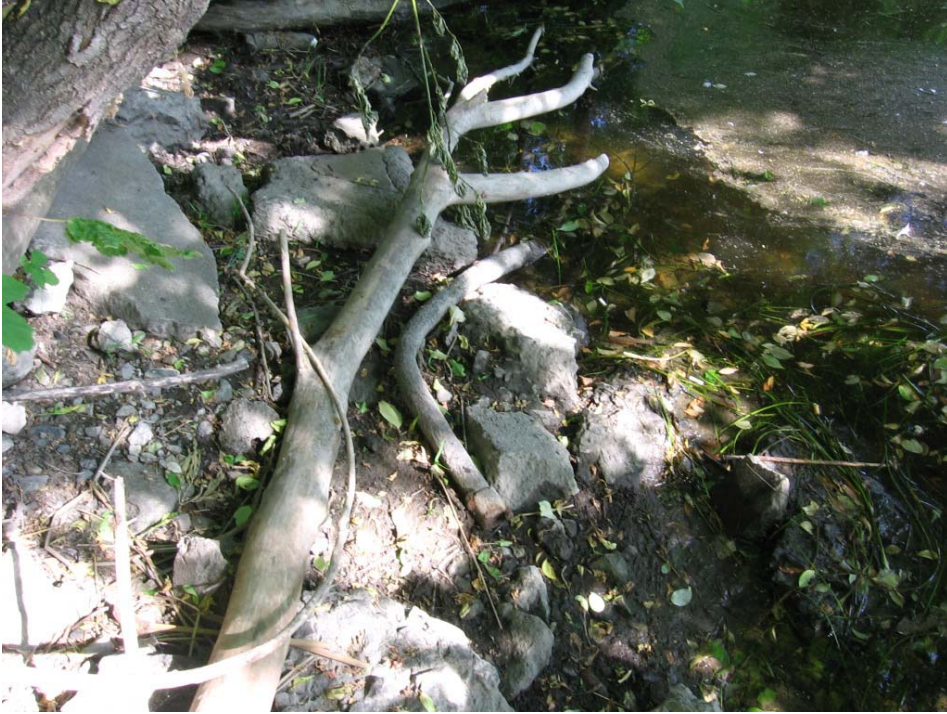
Photo 16. Riparian zone – May 25, 2010.

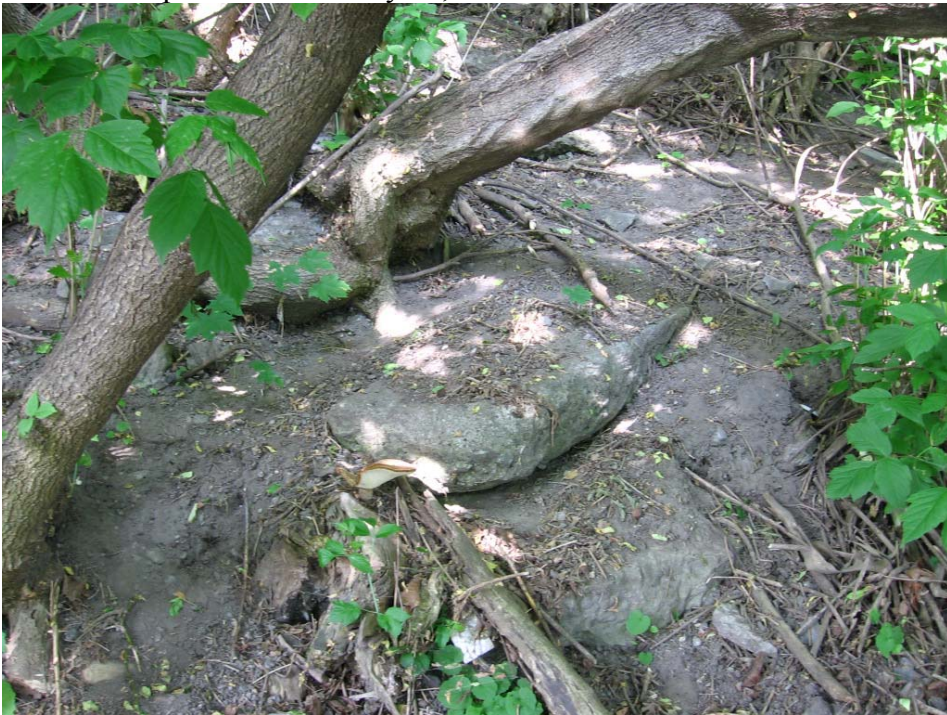
The habitat currently present at the site is a granular mix of fine particle substrate and gravel, and the gravel is fairly embedded. The existing bank is considered erosional and the slope is unstable. Placement of rip-rap is intended to correct this ongoing source of habitat alteration. The habitat change resulting from the project represents a very small proportion of habitat along this section of the Rideau River. It is not apparent that the relevant habitat contributes in any unique or critical manner to the productive capacity of species found in this section of the Rideau River. The habitat changed by the project represents a very small proportion of similar habitat along this section of the Rideau River. The relevant habitat is not considered rare. Species at risk were not identified in this section of the Rideau River.

Photo 17. Eroding slope above the shoreline – May 25, 2010.

- Grading the slope to the angle required to ensure stability;
- Stabilizing the slope with rip-rap; and
- Stabilizing the toe of the slope at the Rideau River with rip-rap.
