ENVIRONMENTAL IMPACT STATEMENT

101 Wurtemberg Street, Ottawa, Ontario

6.2.1 General Map of the Natural Environment

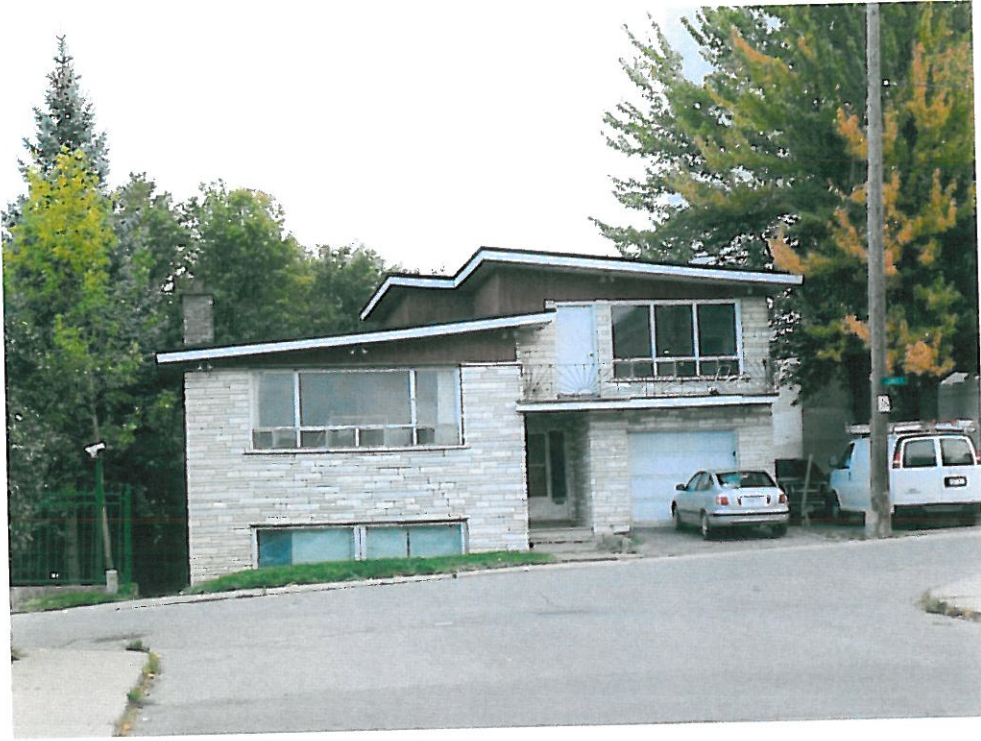
Photo 1. View of existing dwelling at 101 Wurtemberg Street (subject property).

The front section of the property is occupied by the abandoned residence and driveway which are very close to the street (i.e. only 1.5 metre front setback). The grade falls from the south to the north, following the gradient of Wurtemberg Street (photo 1). At the rear of the building is a flat section of yard, where a former swimming pool has been filled in (photo 2), before the property drops steeply toward the Rideau River. At the top of the slope is a chain link fence that prevents access onto the slope. Access is possible, however, from the property to the south where there is no fence at the crest of the slope (photo 5). The slope is vegetated with very low quality trees, while the ground is mostly bare clay with evidence of mixed-in fill. The slope is very steep and treacherous to walk on, as the soil is easily displaced (photo 3).

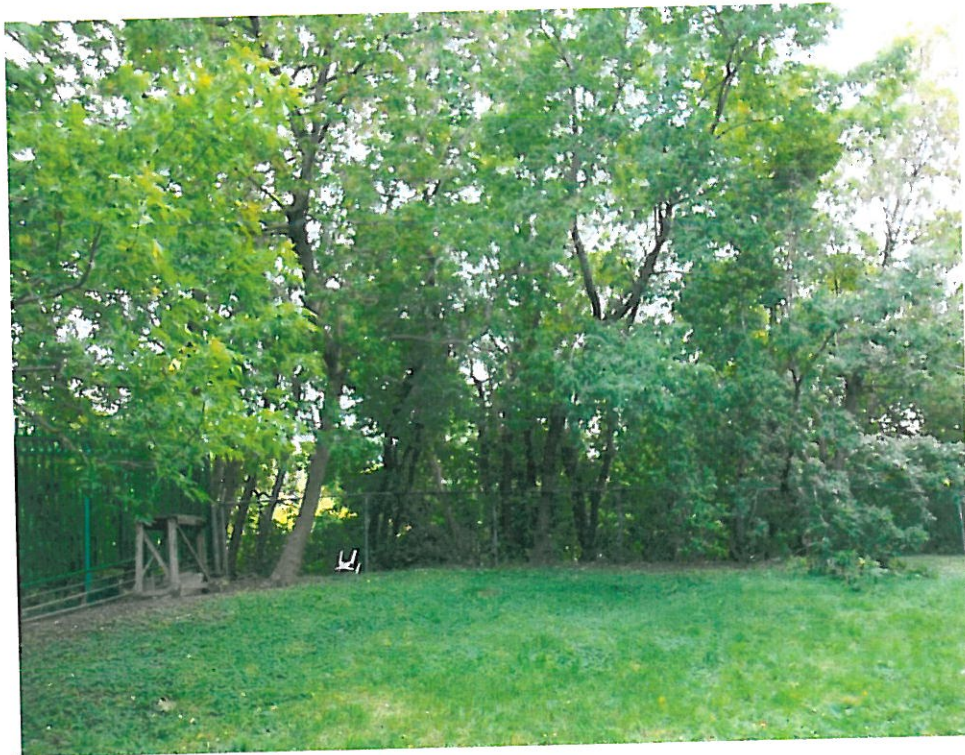
Photo 2. View of rear yard; fence along north side, and trees at crest of slope.

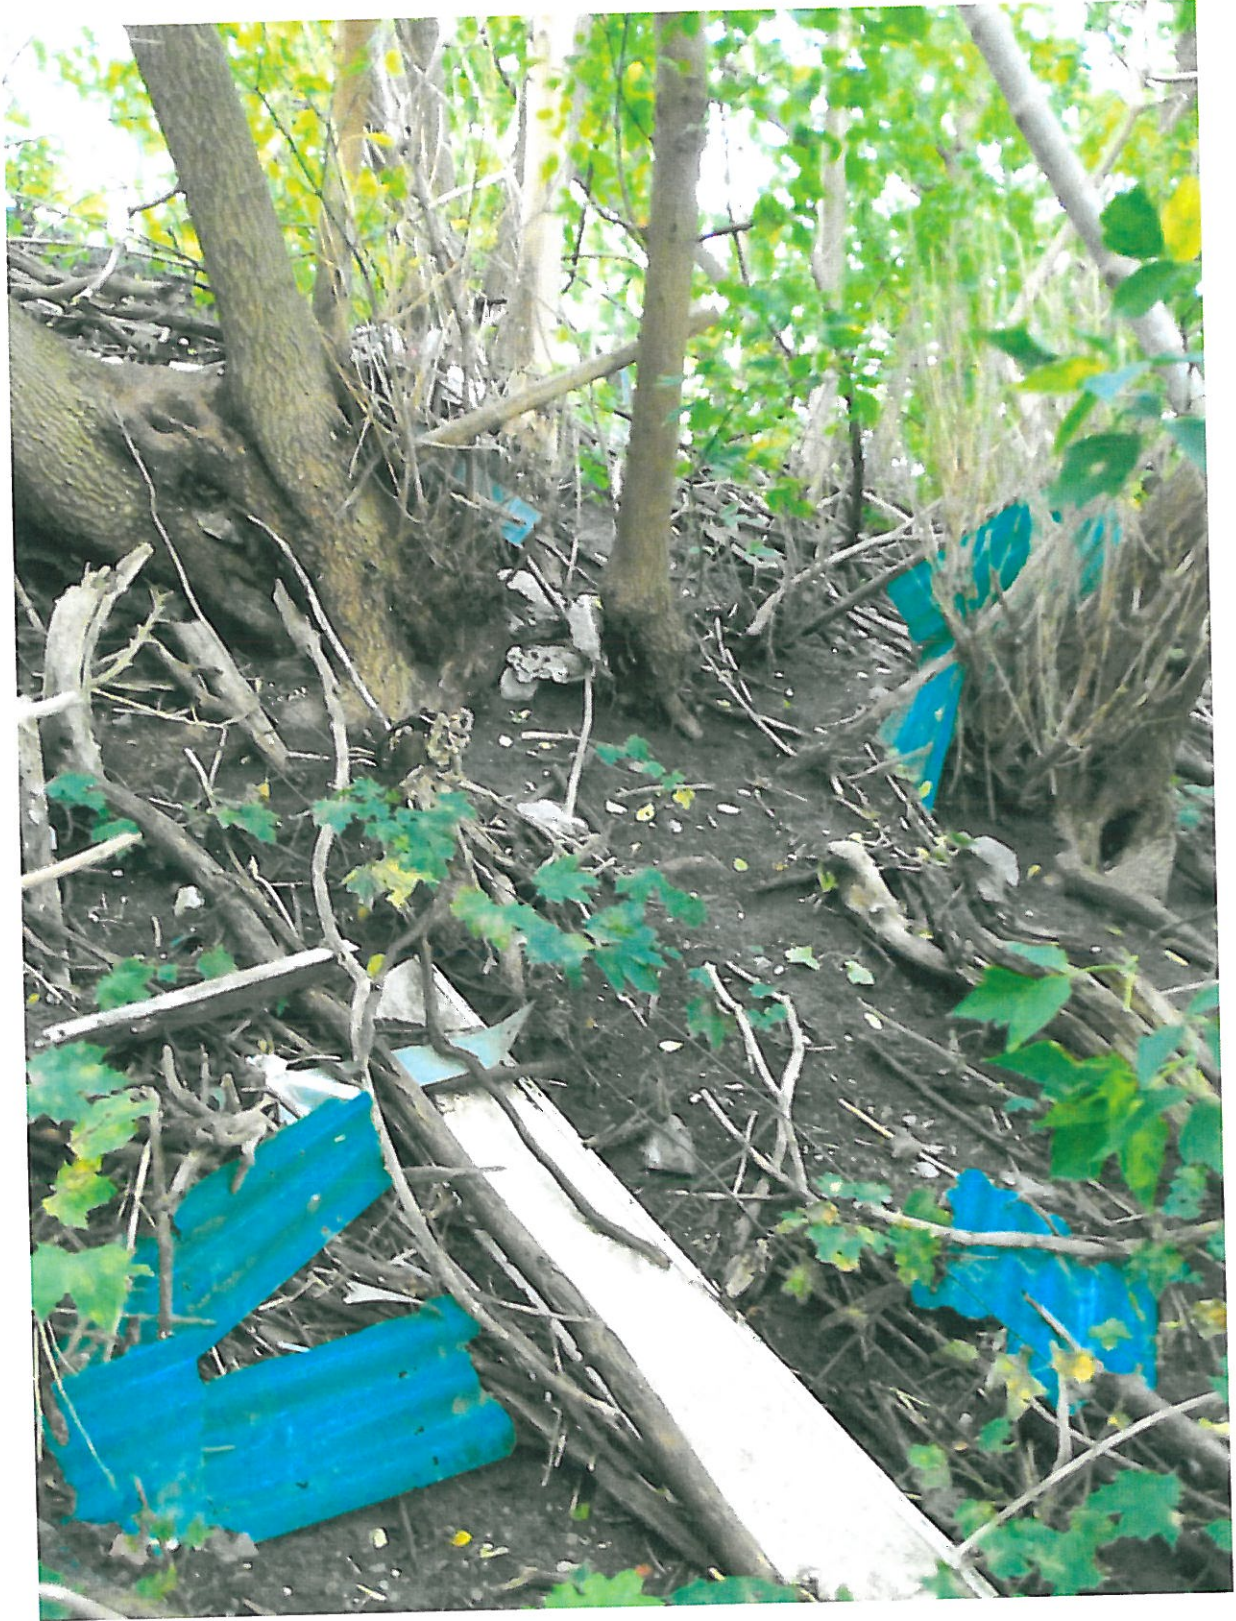
Photo 3. Close-up of slope near the crest

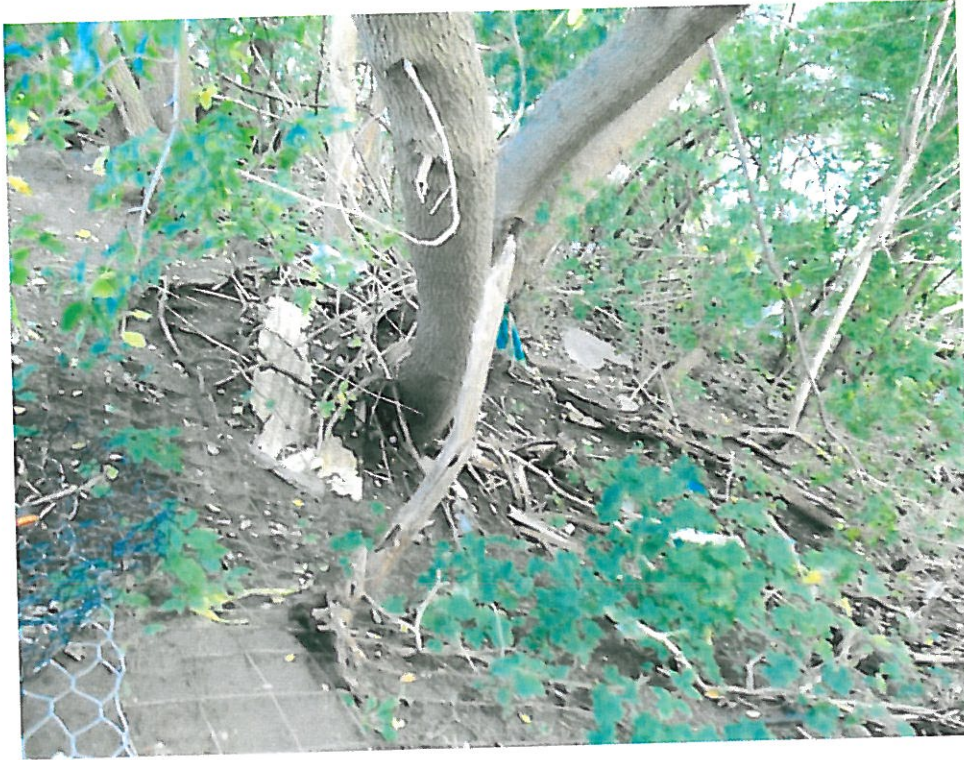
Photo 4. View of crest of slope looking north.

See photos 4, 6, 7, 8, 9, and 10 demonstrating general lack of ground cover and presence of small trees, many of which are growing well off of the perpendicular, and leaning toward the river.

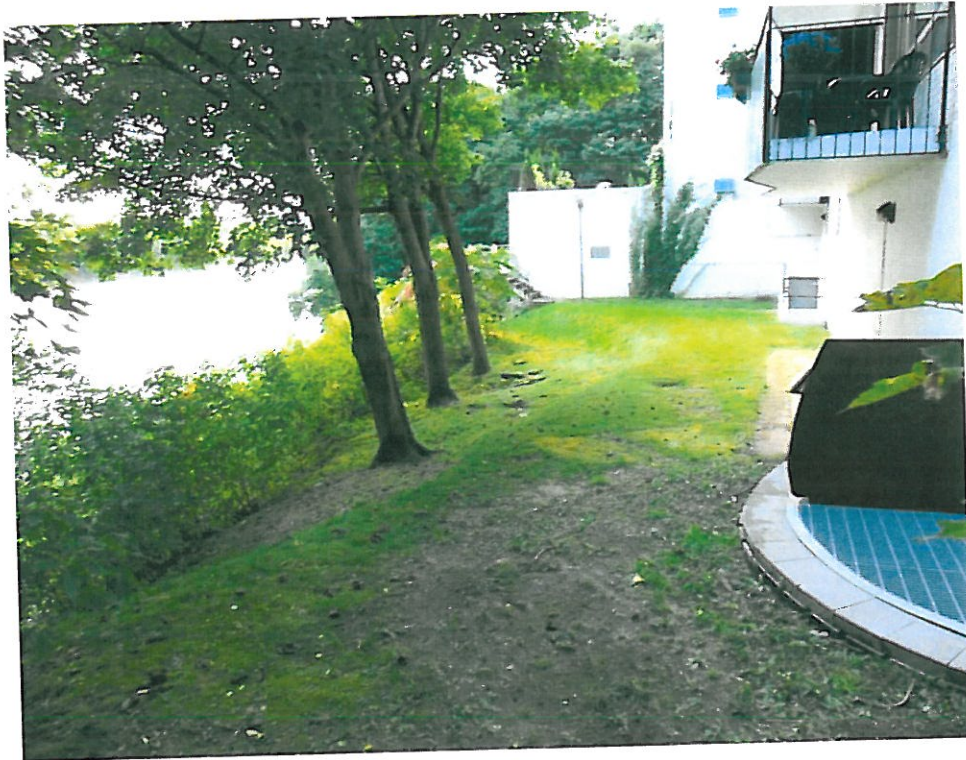
Photo 5. Adjacent property to the south, at a level about 1.2 metres lower than subject site

The property is an existing lot in an established urban setting, with a very large 12 storey apartment building immediately adjacent on the south side (setback 0.3 metres south of the property line), and a 3 storey embassy building on the north side. Both adjacent buildings have rear yard walkout conditions. To the south of the subject site the height of the embankment is about 1.2 metres lower than the subject site, and to the north, the height of the embankment is about 6 metres lower than the subject site.

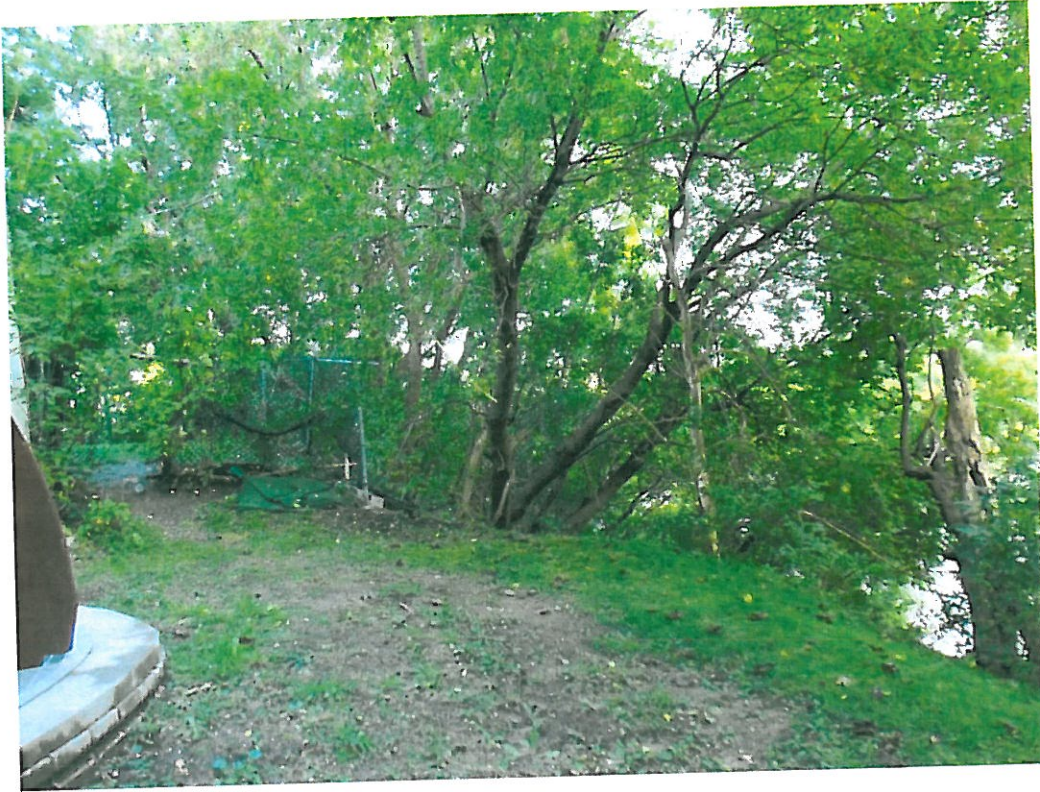
Photo 6. Standing in rear yard of adjacent property, looking north to subject property

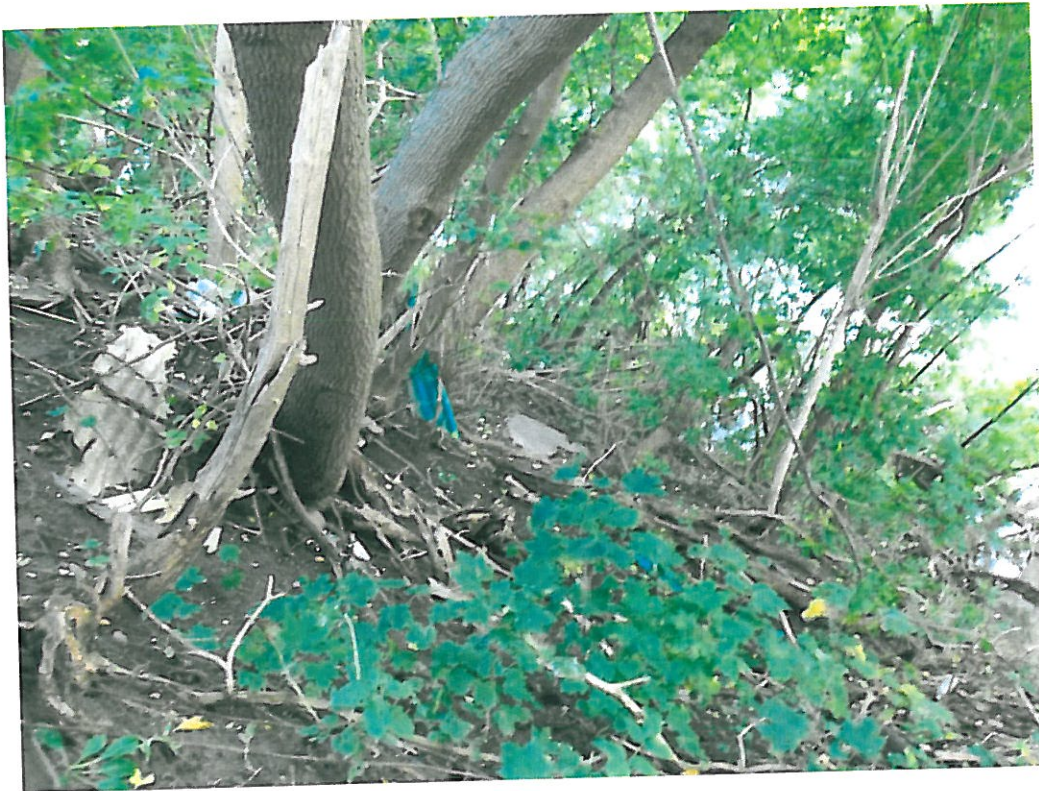
Photo 7. Close-up of fill on slope, and lack of vegetation at grade

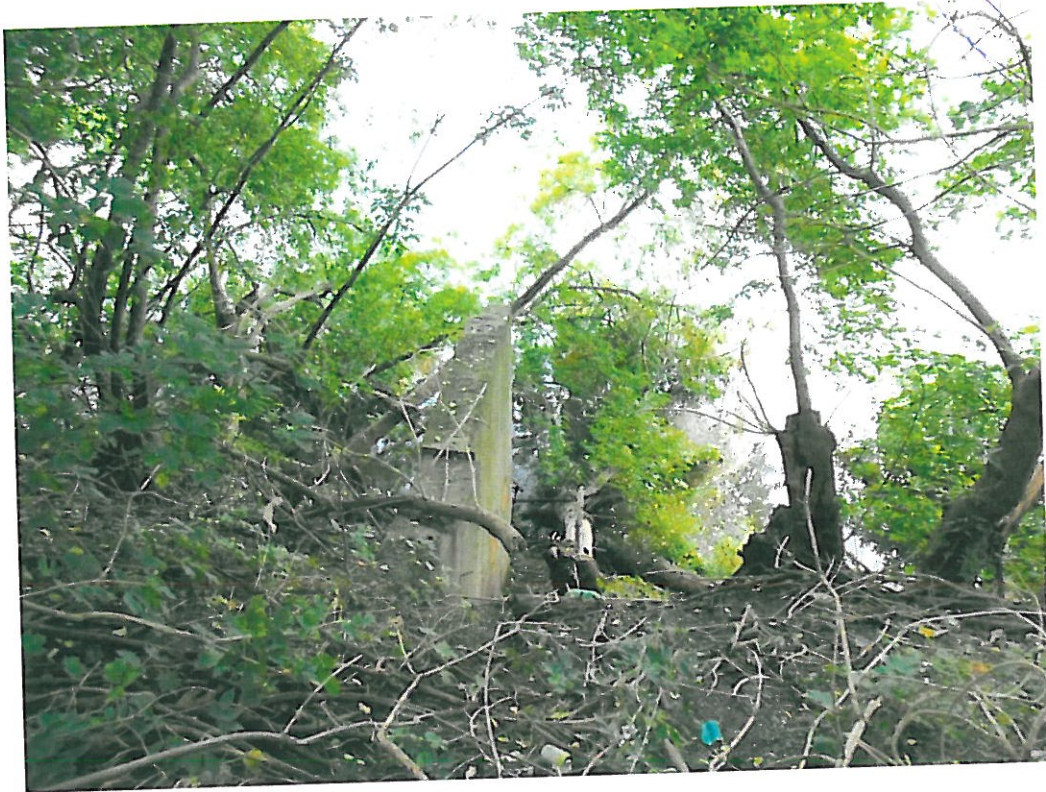
Photo 8. View towards river from top of slope

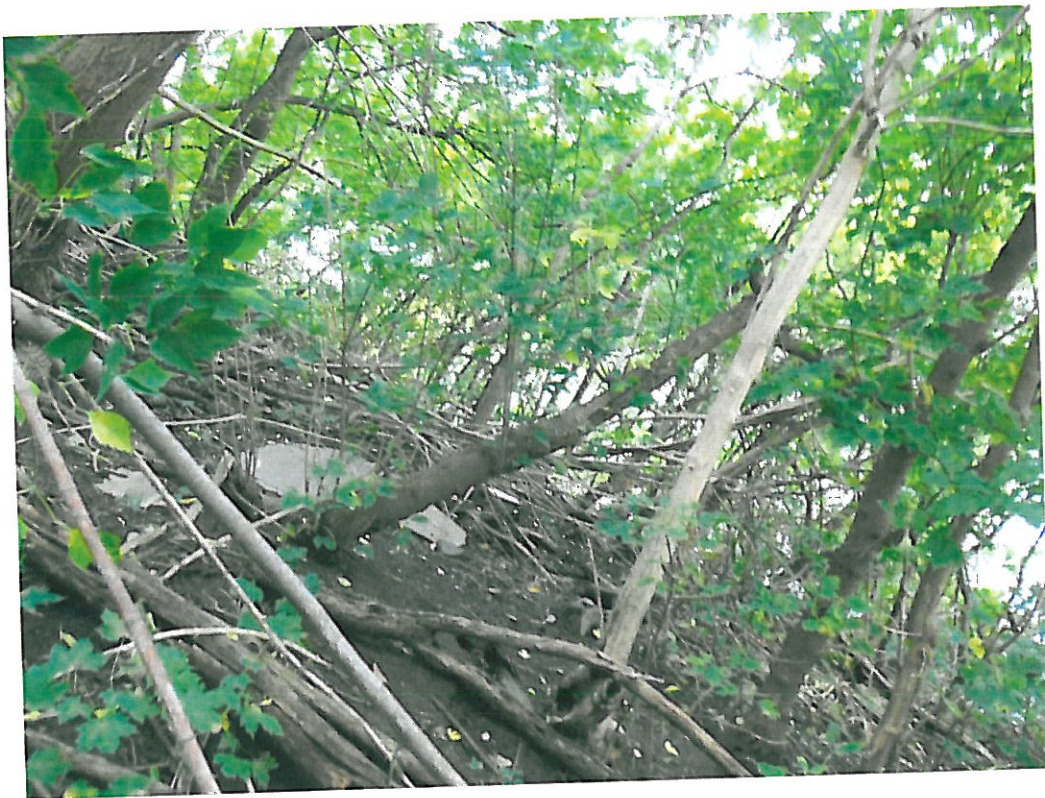
Photo 9. View of slope, with low quality trees growing off perpendicular, leaning toward river

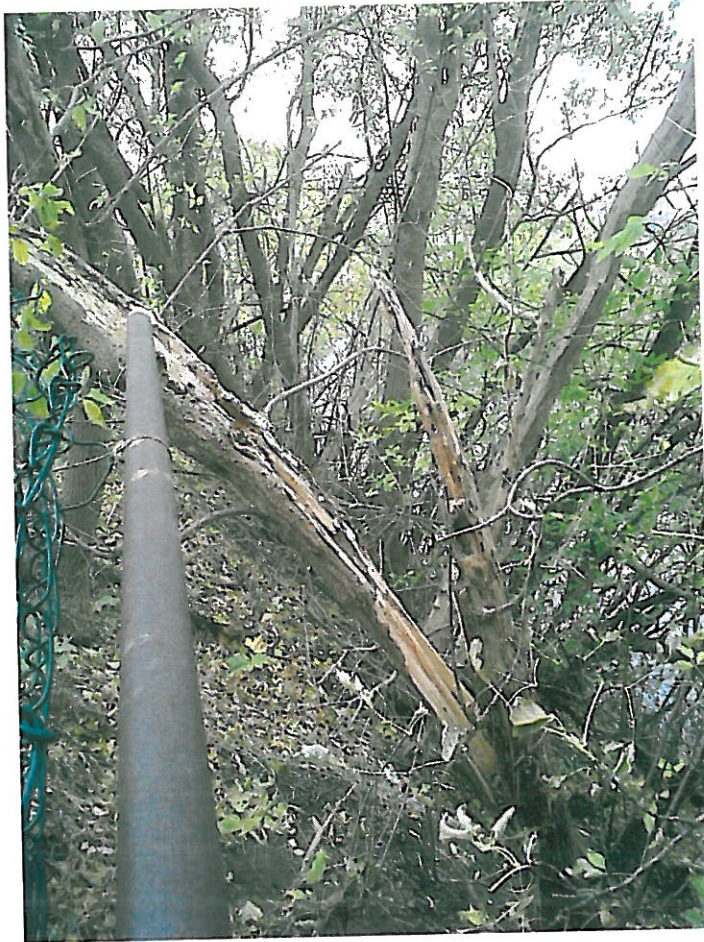
Photo 10. View at crest of slope, looking north, with tree having fallen in early October 2010.

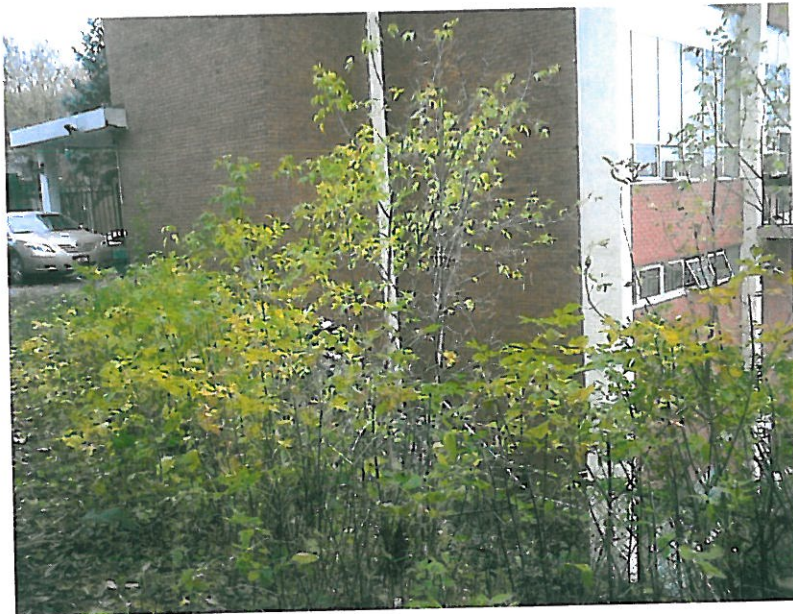
Photo 11. View to the north of adjacent building and grade difference between front and rear of lot.

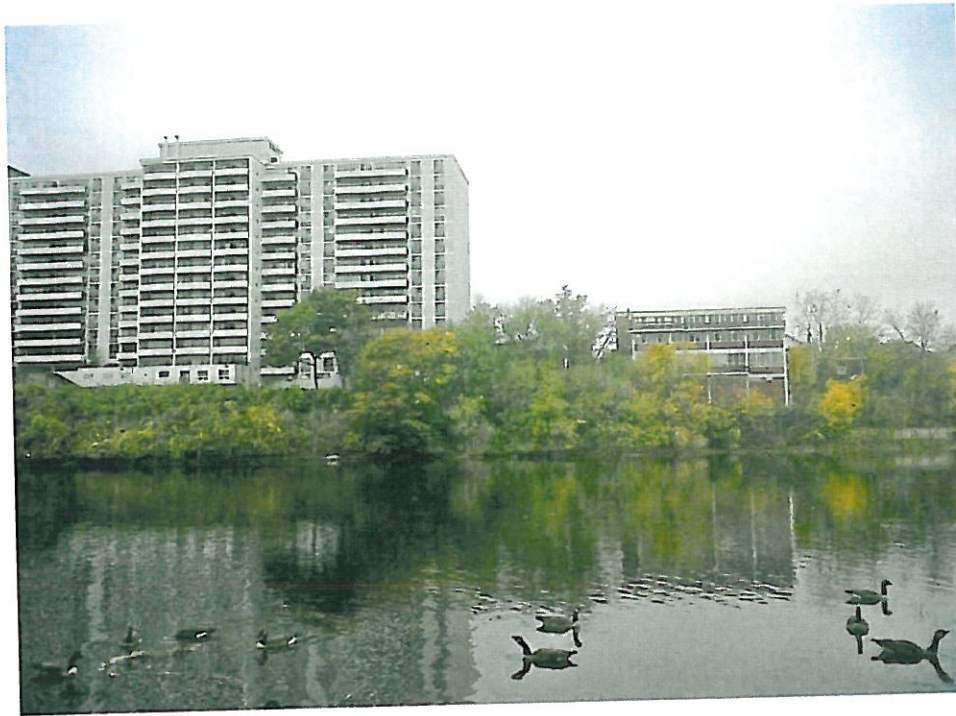
Photo 12. View of shoreline from east side of the Rideau River.

The description of the existing condition states that From Photos 12, 13, and 16, it is apparent that the shoreline has a substantial component that is comprised of broken concrete and granular material. Photos 14 and 15 show the shallow littoral zone where the substrate is comprised of silty material. Some submergent aquatic vegetation and a minor amount of large woody debris were present.

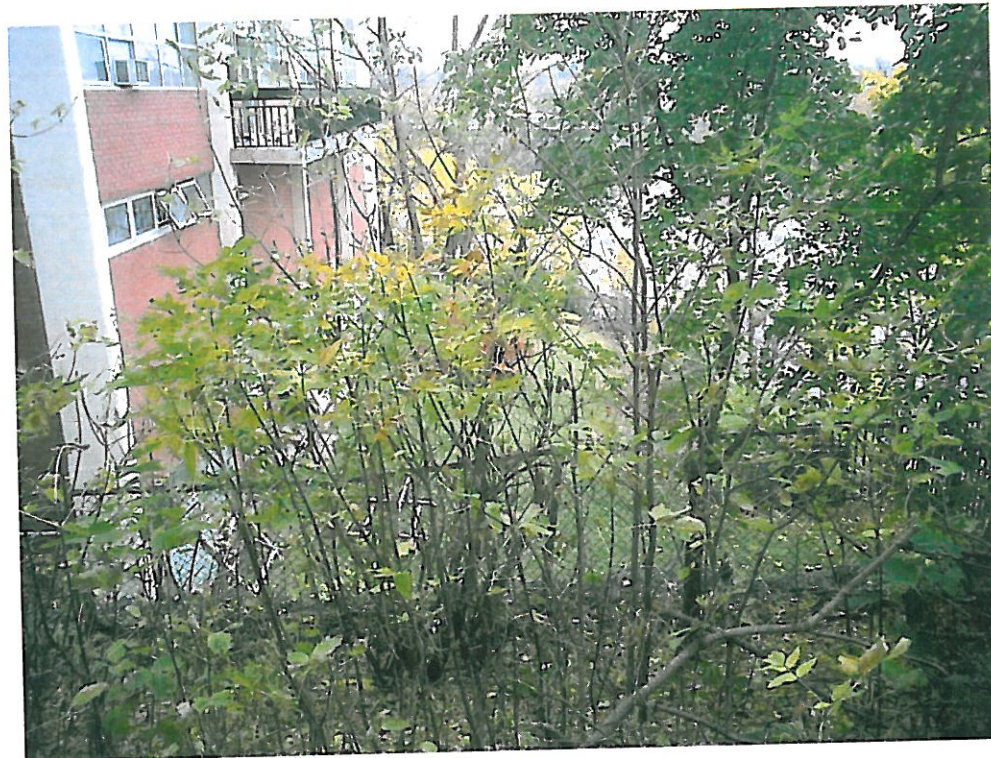
Photo 13. View of rear yard to the north, about 6 metres lower in elevation than subject site.
