REPORT ON

Phase I Environmental Site Assessment 101 Wurtemberg Street Ottawa, Ontario

Report Number: 11-1122-0017

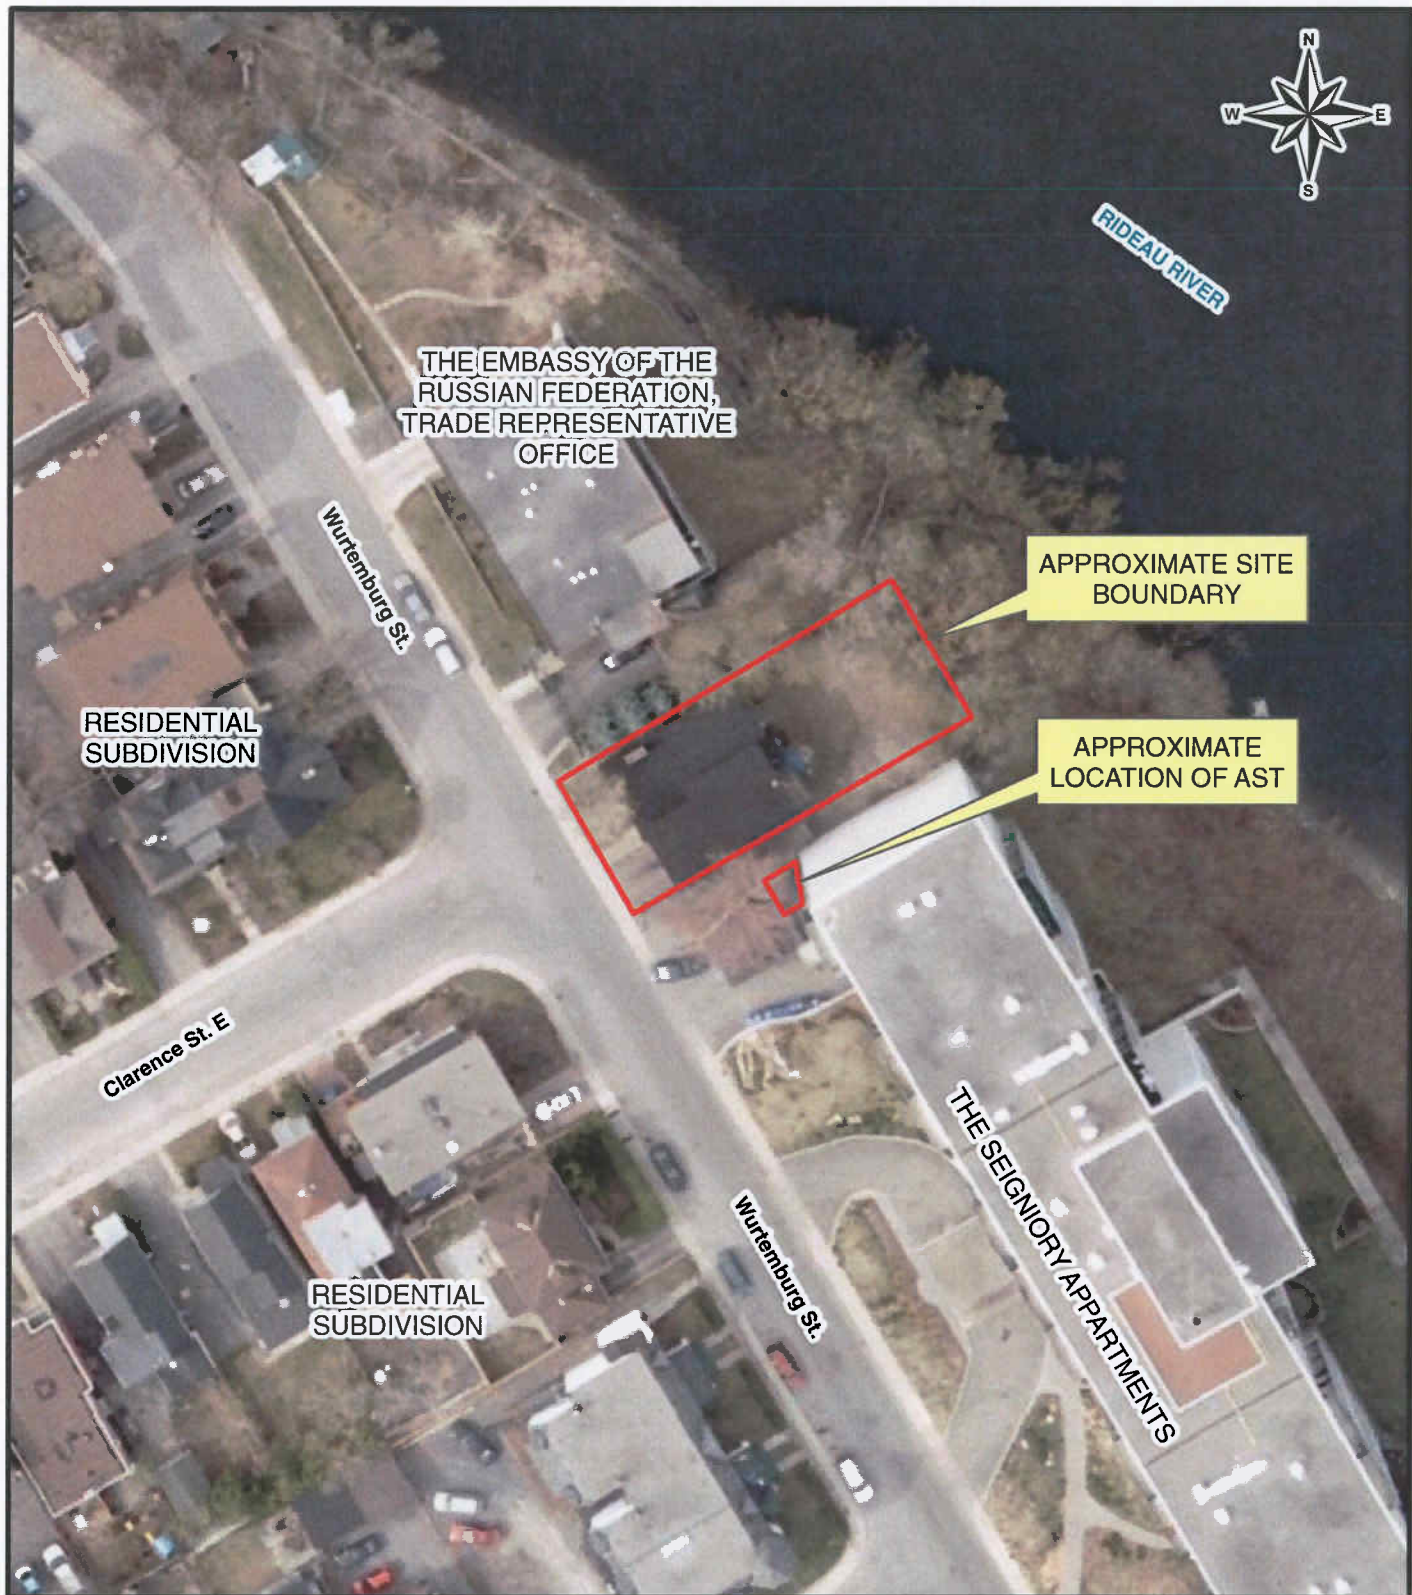
TITLE	SITE PLAN	
PROJECT		
PROJECT No. 10-1122-0017		FIGURE 2
SCALE	AS SHOWN	REV. 0

The general location of the Site is shown on the Key Plan, Figure 1 and the general Site configuration is shown on the Site Plan, Figure 2. Characteristics of the Site, based on the Golder Site visit carried out on February 1, 2011 are as follows:

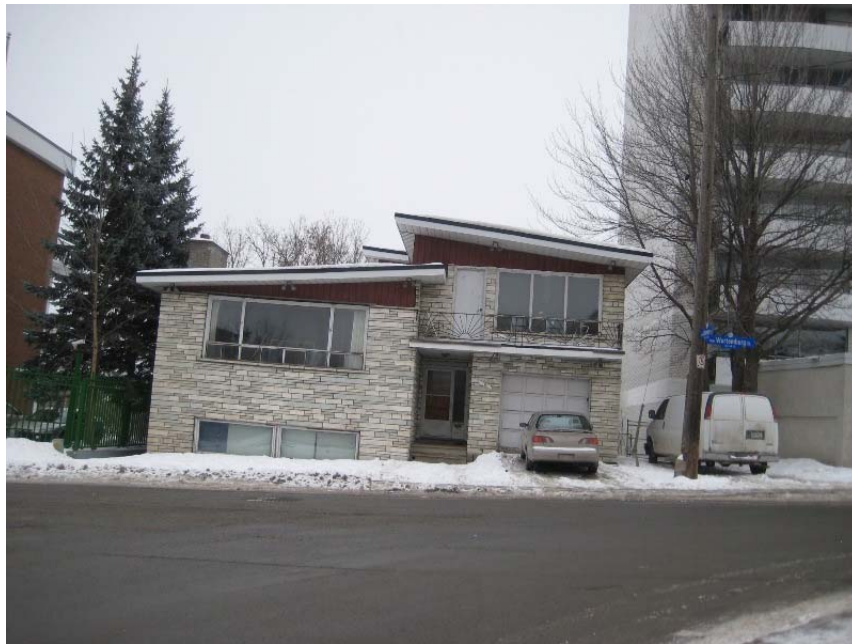
Photograph 1: View looking east, facing Wurtemberg Street towards the front of the Site (101 Wurtemberg Street).

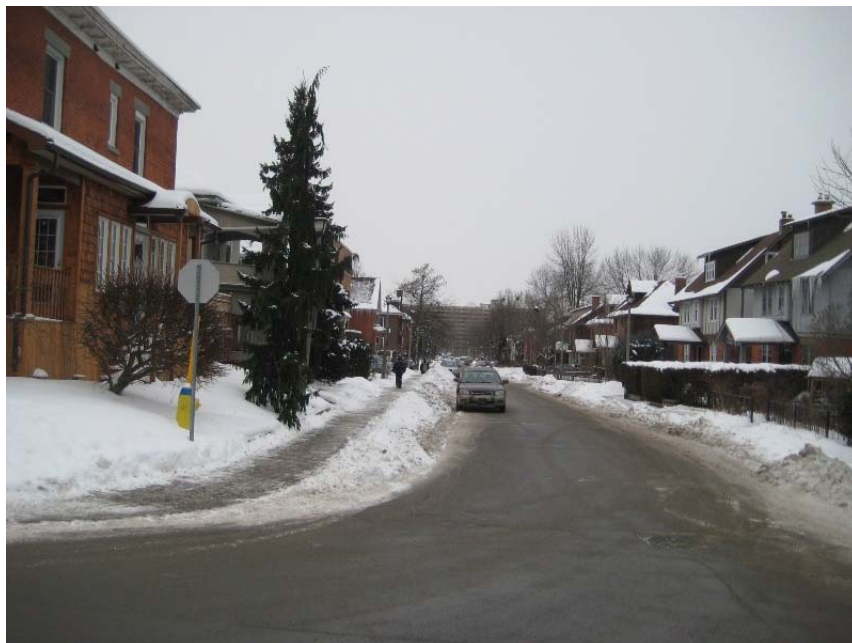
Photograph 2: This is the view looking west from the front of the Site looking down Clarence Street. The surrounding properties are mainly residential.

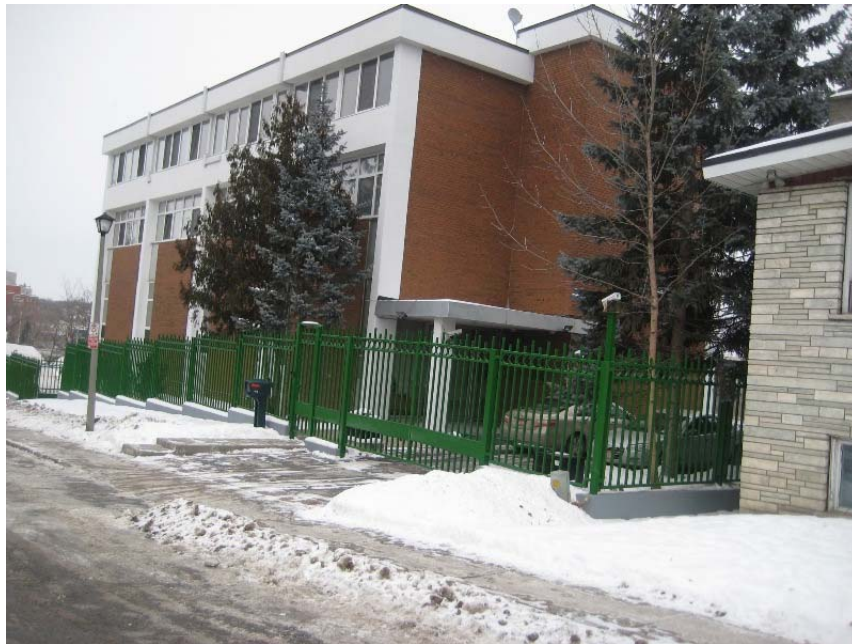
Photograph 3: This is the adjacent property to the north of the Site. It is currently occupied by the Russian Embassy –Trade Representative Office.

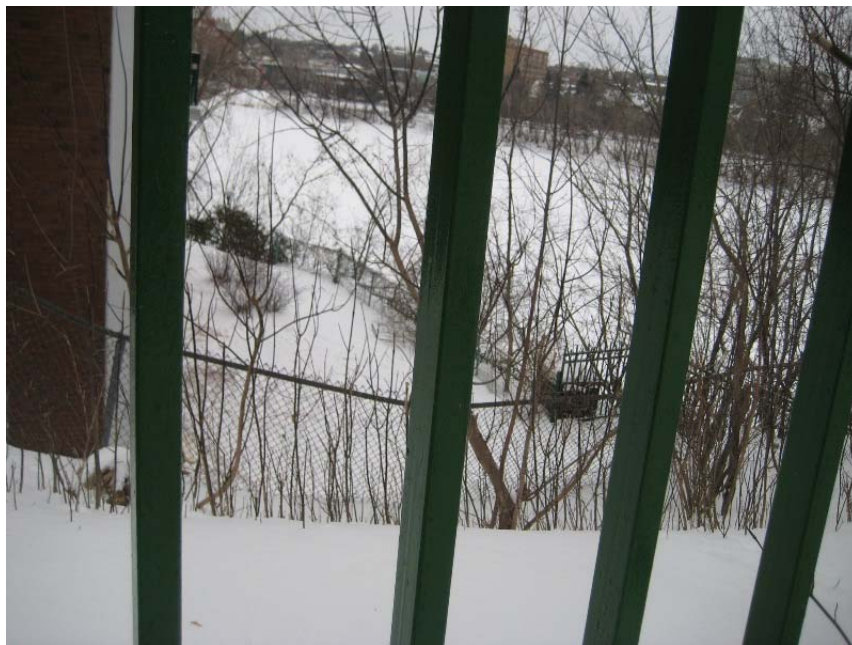
Photograph 4: This is the view of the adjacent property (The Embassy of the Russian Federation –Trade Representative Office) to the north, with a view of the Rideau River in the background. There is a significant drop in elevation between the Site and the adjacent properties to the north and south, which becomes apparent when you look from the east side of the Site.

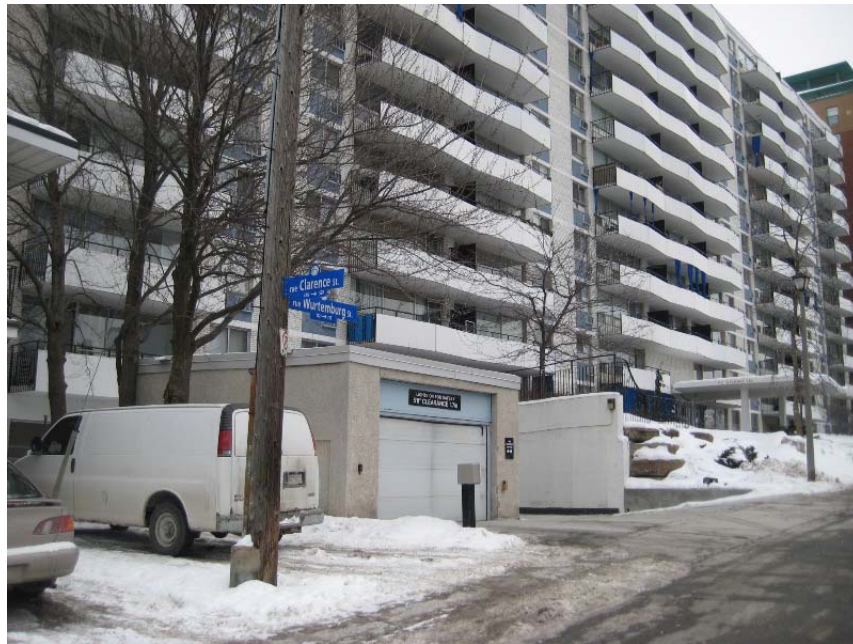
Photograph 5: This is the adjacent property to the south, consisting of the apartment (The Seignior Apartments), and underground parking garage. This property is heated by natural gas.

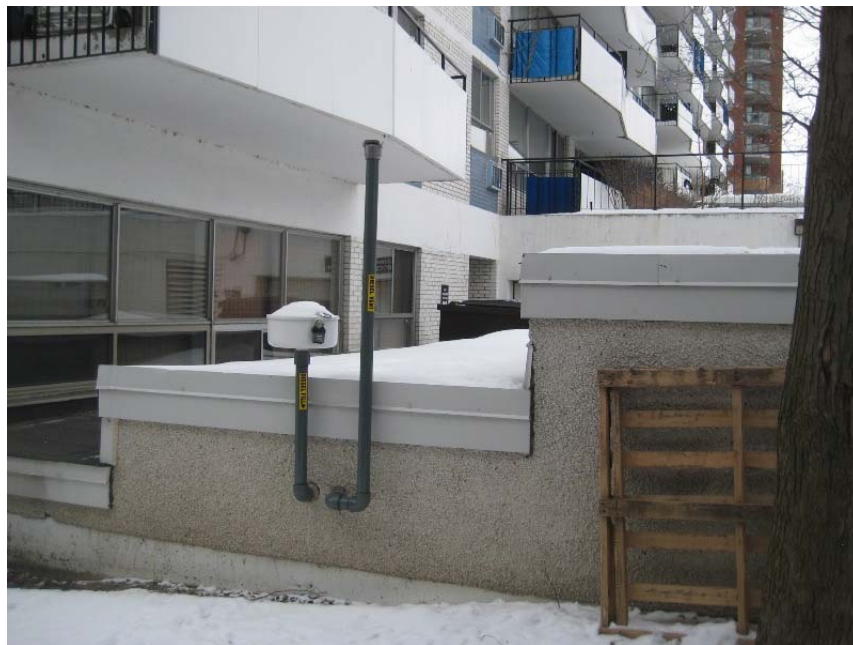
Photograph 6: View looking south towards the vent and fill pipes associated with the apartment buildings. It is interpreted that these pipes connect to an aboveground storage tank in the parking garage, which is used to fuel a backup generator. These pipes are located approximately 10 m away from the property.

No ASTs were observed on the Site. The Site Representative indicated that he is not aware of the presence of any former AST on the Site. Piping likely associated with an AST was observed on adjacent lands within 10 m south of the Site. This piping is thought to be associated with a backup generator on the apartment building complex rather than a source of heating. A tank fill monitor was mounted on the exterior of the apartment building, indicating that there is a system in place to prevent spills and overfills of the AST. This AST is not interpreted to be an issue of potential environmental concern. In addition, it was observed that the apartment building to the south and other residences to the west of the Site area are heated by natural gas, indicating less potential for heating oil ASTs in the surrounding properties. The source of heating of the embassy to the north of the Site was not identified at the time of the Site visit.

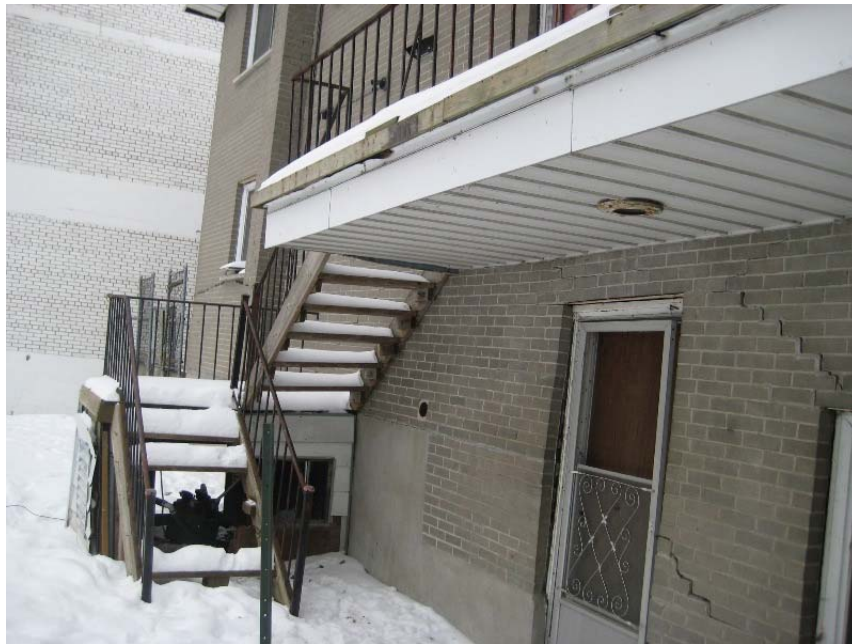
Photograph 7: View looking south towards the east-facing exterior building wall, showing structural damage to the stairs and foundation (visible cracks).

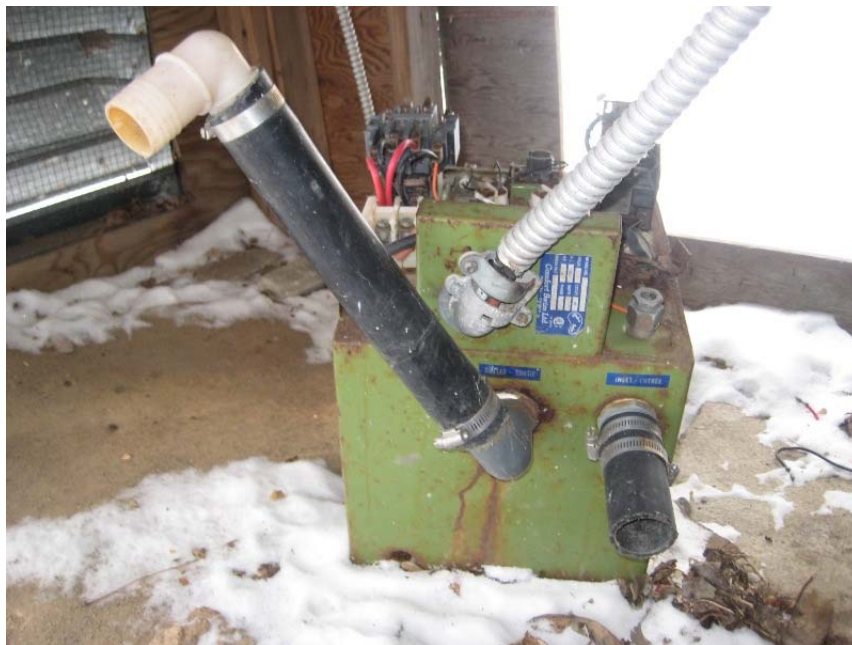
Photograph 8: View of a heating apparatus found underneath the exterior stairs, with visible electrical input and pipes for liquid input and output. This is thought to be associated with a former swimming pool on Site.

Given that the Site is currently unoccupied, it is unlikely that solid waste is being generated. During the Site visit, an electrical heating apparatus was observed beneath a staircase east of the building. It is likely that this electrical apparatus was associated with the former swimming pool, which was observed in the 1988 and 1997 aerial photographs.

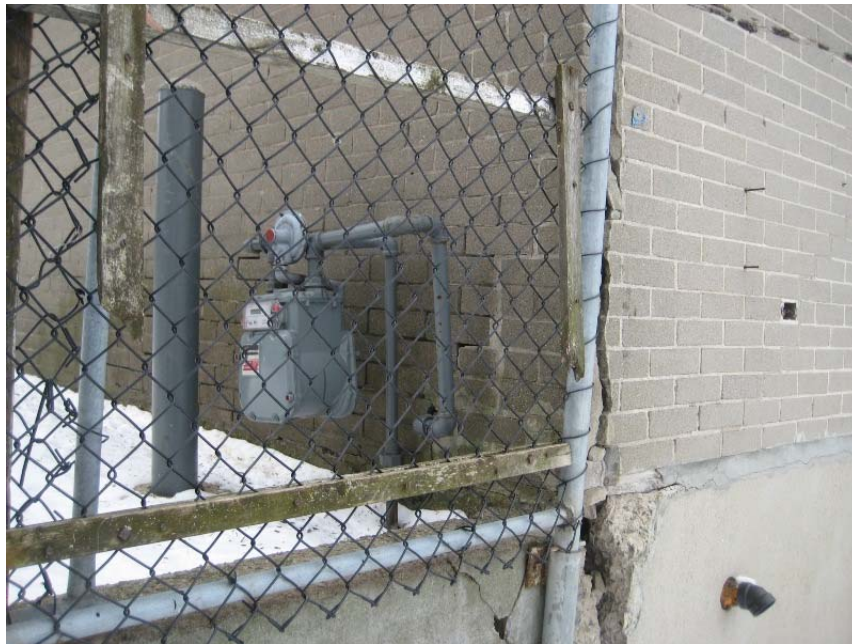
Photograph 9: View of the Southeastern corner of the building, showing evidence that the Site has natural gas heating.

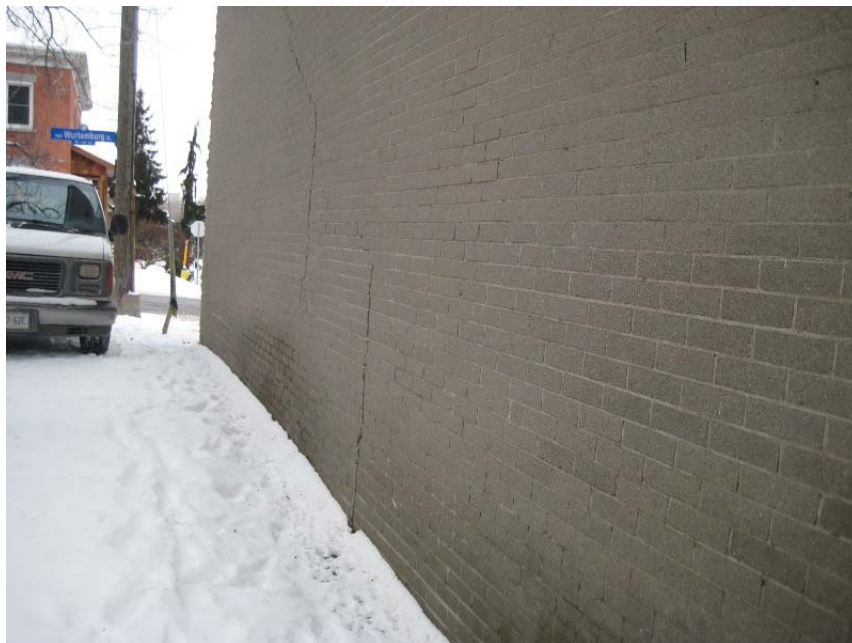
Photograph 10: View looking west towards the south-facing exterior wall showing further structural damage. This photograph also shows a utility pole with what is thought to be a source of electricity to the Site (hydro wires). There were no pole-mounted transformers observed on the Site or nearby.

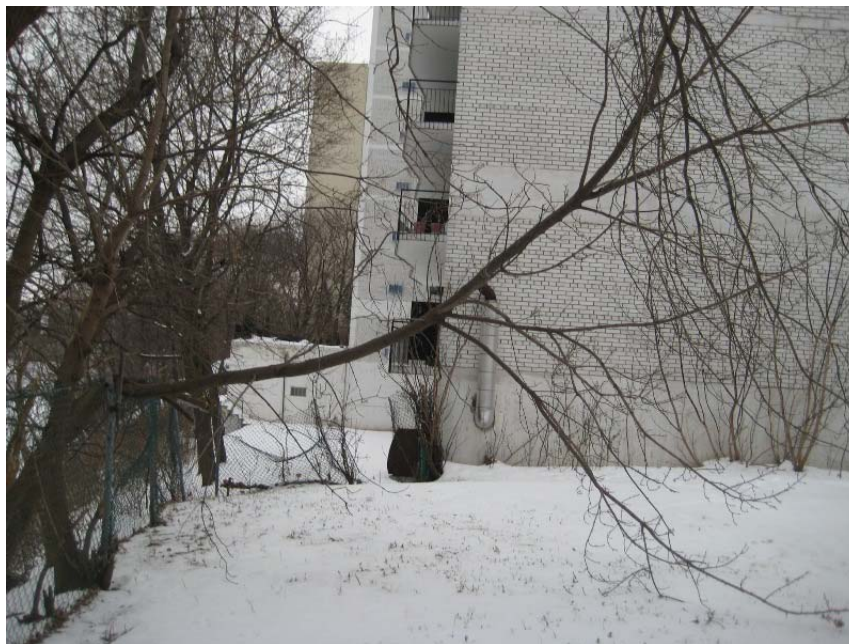
Photograph 11: View looking south towards the adjacent property. This photo shows an air vent, which was releasing air emissions in the vicinity of the south-eastern portion of the Site.

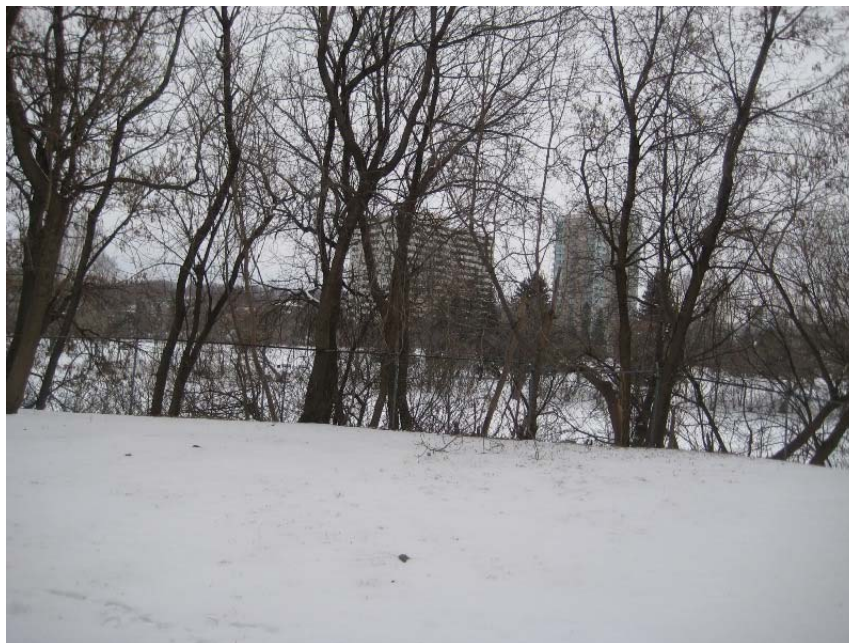
Photograph 12: View looking east towards the eastern portion of the Site (covered by snow). The fence is interpreted to mark the property boundary, and vegetation has filled the slope leading down to the Rideau River. The buildings visible in the distance are on the opposite site of the Rideau River.

The Site is generally flat but there is an elevation difference between the Site and the surrounding lands east of the Site. The slope of the area is downwards towards the north-northwest. At the time of the Site visit, the exterior ground surface was snow-covered, which limited the observations of issues of potential environmental concern (i.e. stains, sheens, or stressed vegetation) at the Site. At the time of the Site visit, no piles of fill material were observed on the Site. Based on the slope stability assessment completed for the Site by Golder (2010), fill material may be present on-Site ranging in thickness between 0-3 m. Due to the fact that the origin and quality of the fill material are unknown, it is considered that presence of fill material is an issue of potential environmental concern.
